HISTORIC DOWNTOWN PONCA CITY DESIGN GUIDELINES MANUAL

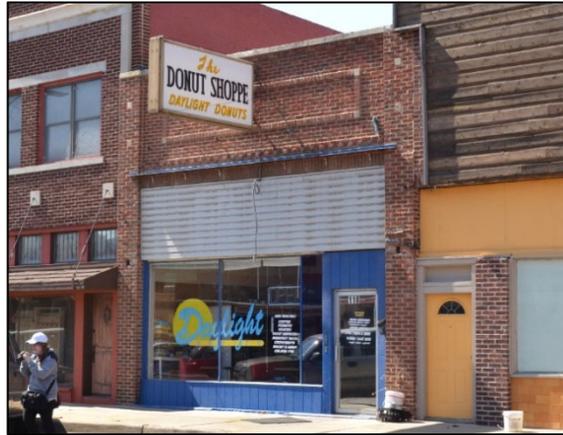
Figure 4: 118 N 3rd (1930). One-Part Commercial Block, Twentieth Century Commercial Style [2018 Survey].

One-Part Commercial Block. The One-Part Commercial Block building is a simple one-story building often with a decorated upper façade (Figure 4). In many examples, the façade comprises little more than plate glass windows and an entrance with a cornice or parapet spanning the width of the façade (Figure 5).

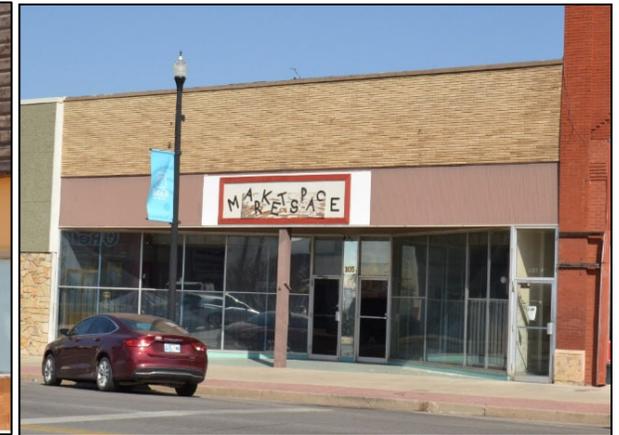
Figure 5: 105 West Grand (c. 1940). One-part Commercial Block, Minimal Commercial Style [2018 Survey].

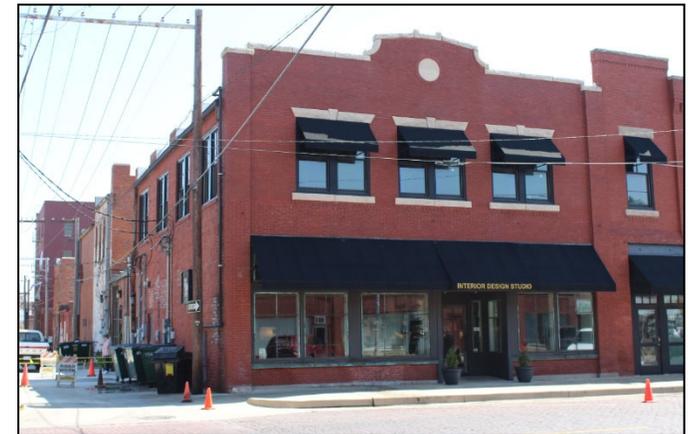
Figure 6: 105-109 North 2nd Street (c. 1925). Two-Part Commercial Block, Twentieth Century Commercial Style [2018 Survey].

Two-Part Commercial Block. Two-Part Commercial Block buildings are typically two - to four- stories in height. They have a clear visual separation of use between the first-story customer service/retail space and the upper-story office, meeting room, or residential uses. The styling of the first story focuses on the storefront glazing and entrance(s). The design of the upper stories identifies the building's architectural influences. Sometimes these influences are substantial enough to discern a specific style (Figure 6).

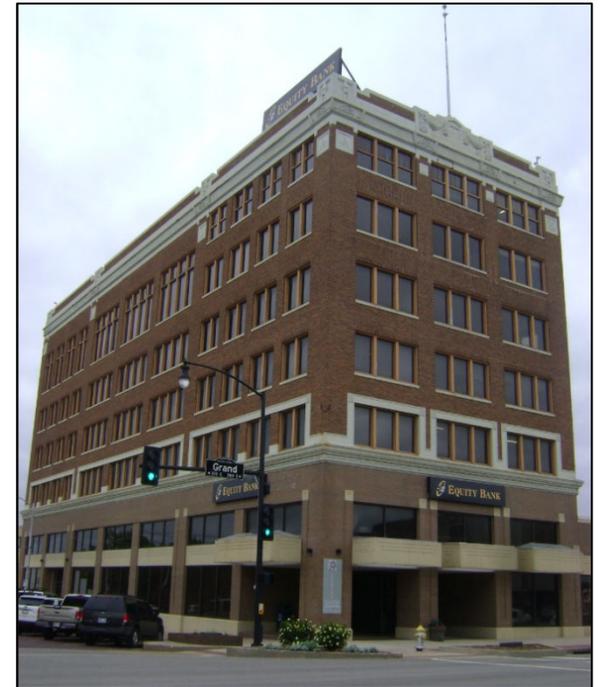
Figure 7: Masonic Building, 222 East Grand (1924), Two-Part Vertical Block, Classical Revival [Rosin Preservation].

Two Part Vertical Block. The Two-Part Vertical Block is a taller version of the Two-Part Commercial Block (over four stories) with a clear visual separation between the first story, or the “base,” and the upper stories, or the “shaft.” The design of the upper stories identifies the building’s architectural influences and often uses decorative or structural elements to emphasize the verticality of the building. Ponca City has one example of the Two-Part Vertical Block: 222 East Grand (Masonic Building/Equity Bank) (Figure 7).

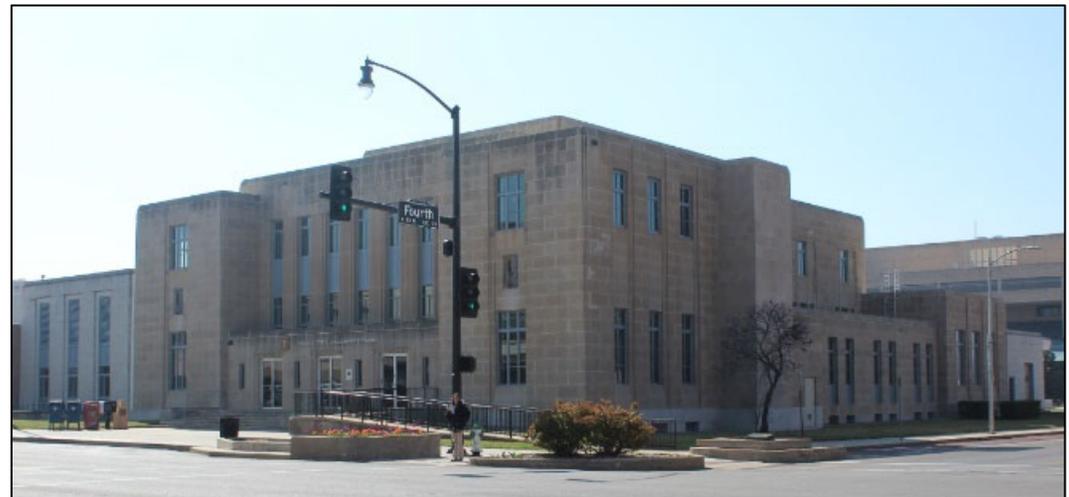
Figure 8: Federal Building, 402 East Grand Avenue (1935), Central Block with Wings, WPA Moderne [2018 Survey].

Central Block with Wings. The Central Block with Wings are two to four stories in height with a centralized, projecting portion between two smaller units. Banks and government buildings frequently used this form. In Ponca City, there are two examples of this commercial form, and both are government buildings: 402 E Grand (US Post Office and Federal Building) (Figure 8) and 516 E Grand (Municipal Complex).

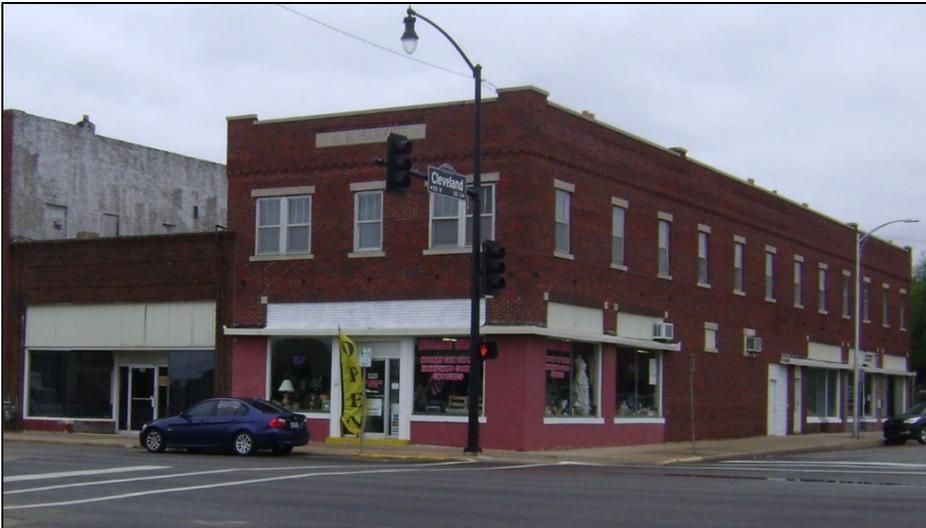
Figure 9: At right, Hawkins Hotel, 201 North 1st Street (1930), Two-Part Commercial Block, Commercial Style; at left, Howe Baking Company Building, 203 North 1st Street (c. 1930), One-Part Commercial Block, Commercial Style [Rosin Preservation].

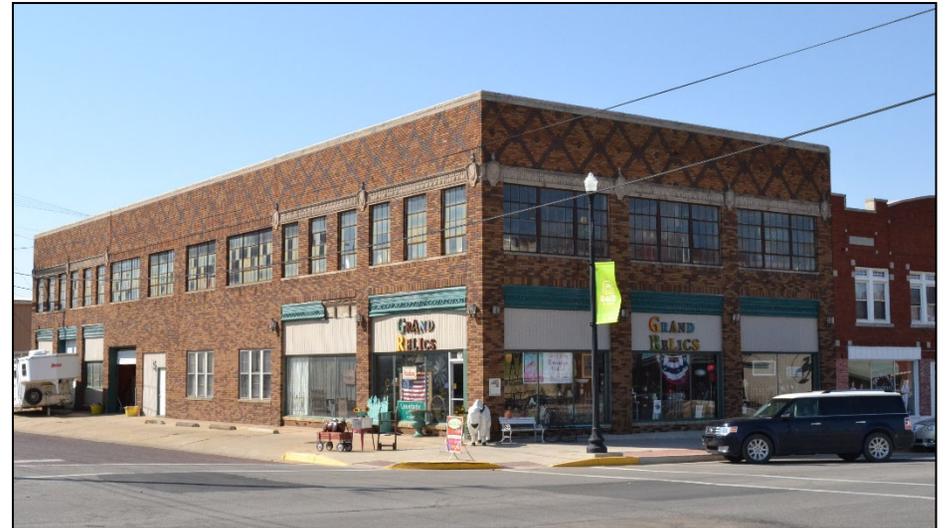
Figure 10: Savage Motor Company Building, 200 West Grand Avenue (1927), Two-Part Commercial Block, upper windows are steel with central awning sash [2018 Survey].

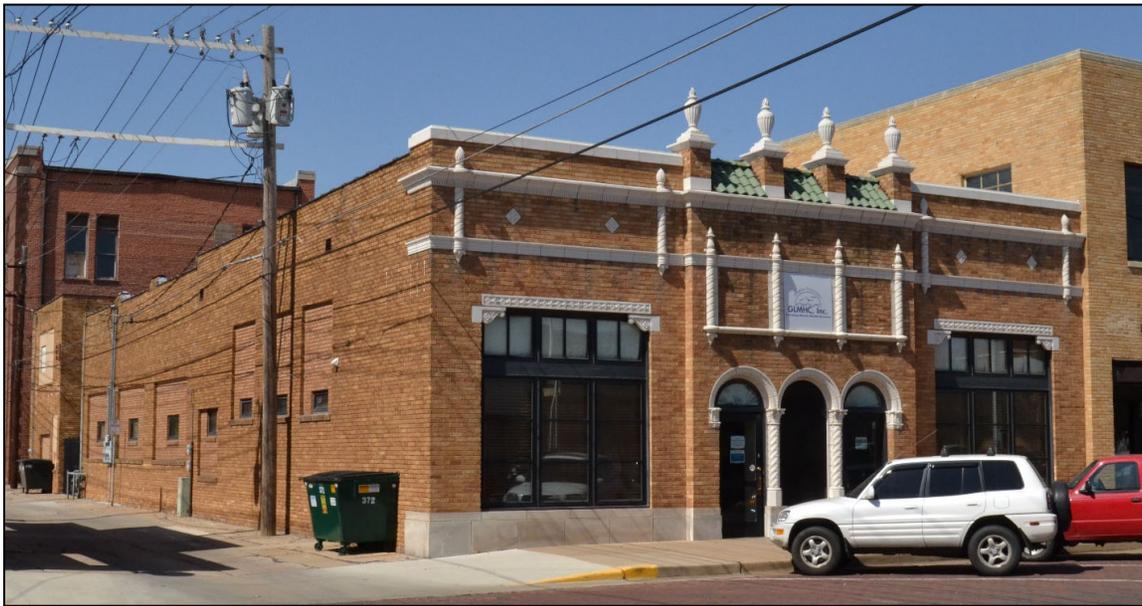
Figure 11: Howe Building, 110-114 North 4th Street (1927), One-Part Commercial Block, Spanish Colonial Revival [2018 Survey].

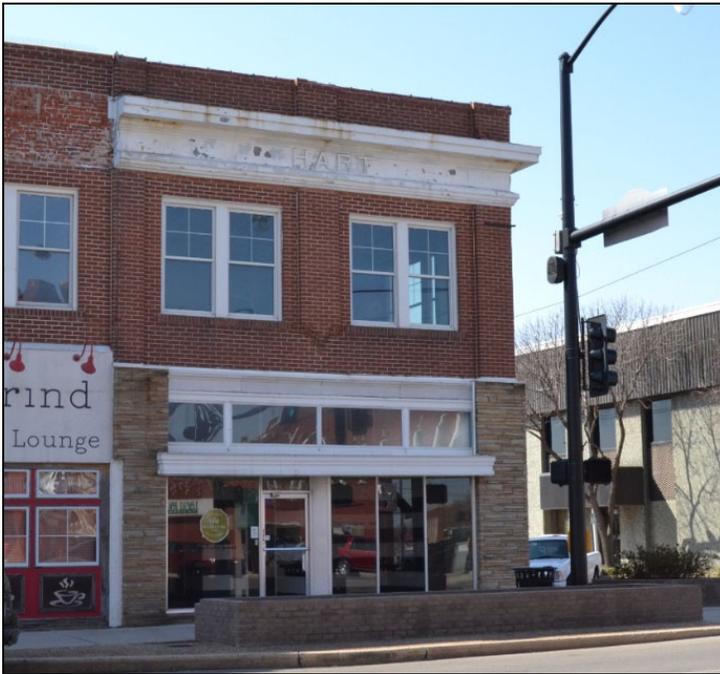
Figure 12: Hart Building, 200 East Grand (1928), Two-Part Commercial Block, Classical Revival details in upper level [2018 Survey].

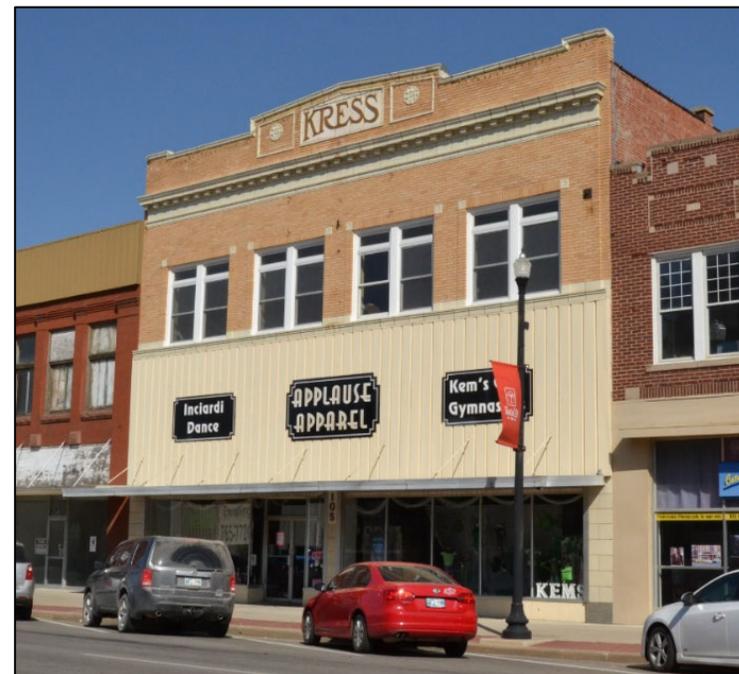
Figure 13: Kress Department Store, 105 East Grand (1928), Two-Part Commercial Block, Classical Revival details in upper level [2018 Survey].

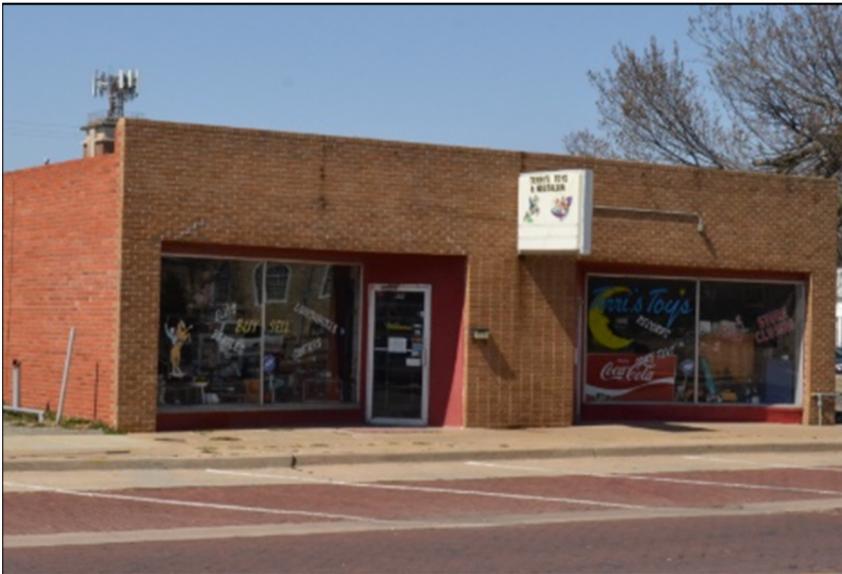
Figure 14: 212 North 3rd Street (1930). One-part Commercial Block, Minimal Commercial Style [2018 Survey].

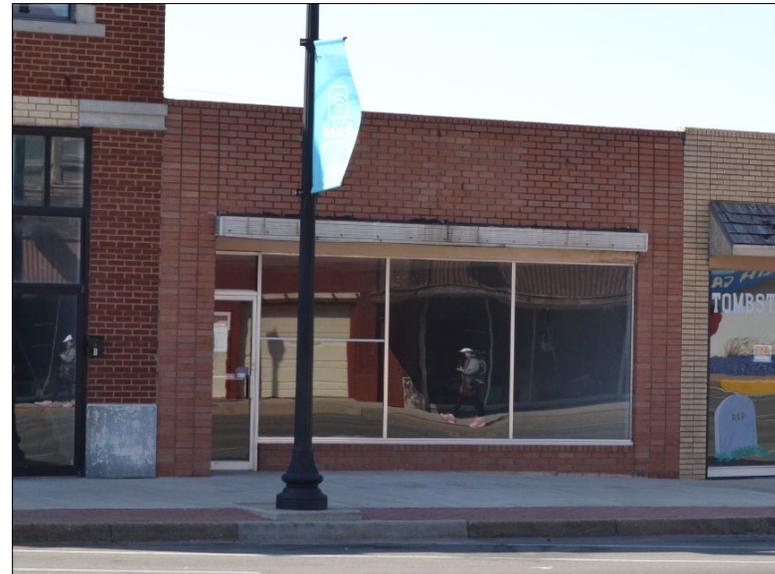
Figure 15: Peter Pan Cleaners, 216 West Grand (1940), One-Part Commercial Block, Minimal Commercial Style [2018 Survey].

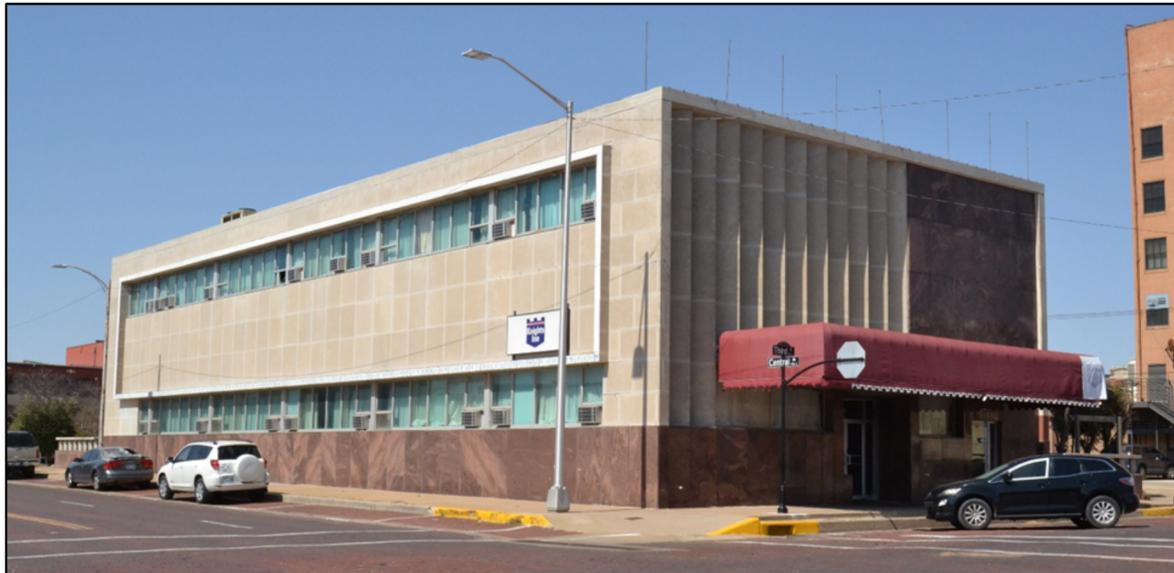
Figure 16: Ponca City Savings and Loan, 120 South 3rd Street (1956), Modern Movement [2018 Survey].

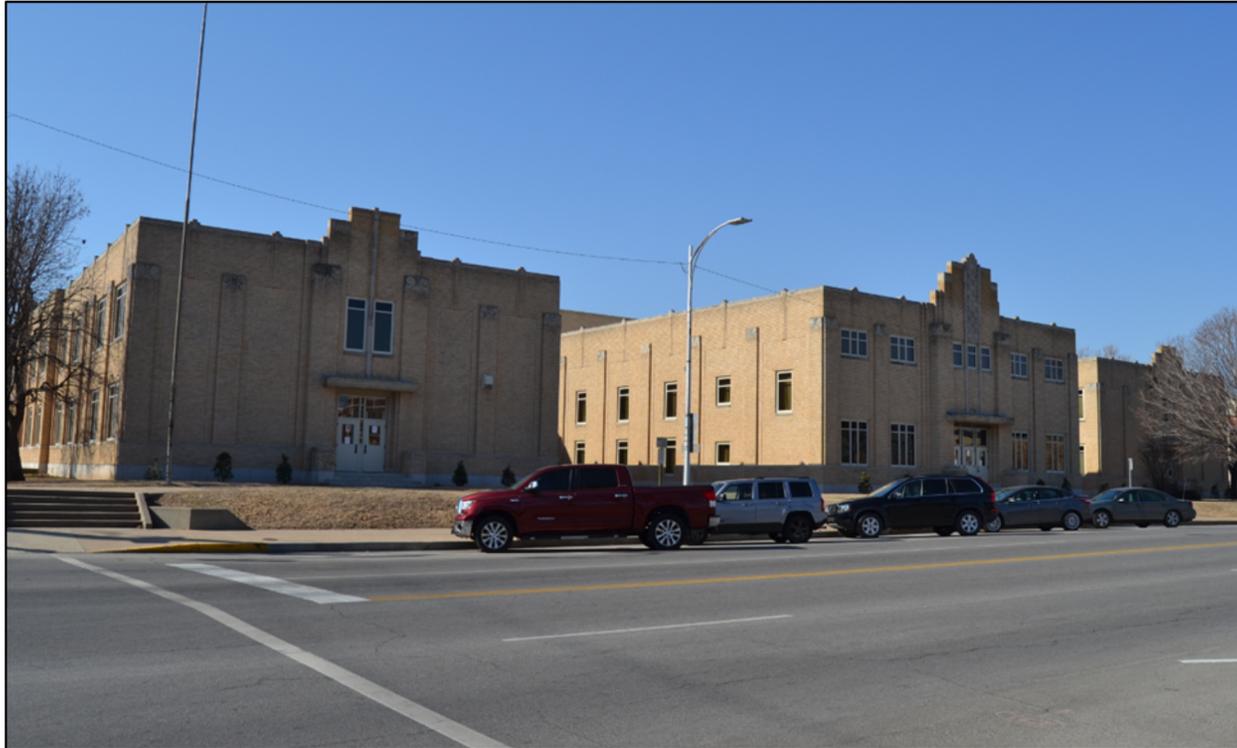
Figure 17: Ponca City East Middle School, 612 East Grand Avenue (1939), Art Deco [2018 Survey].

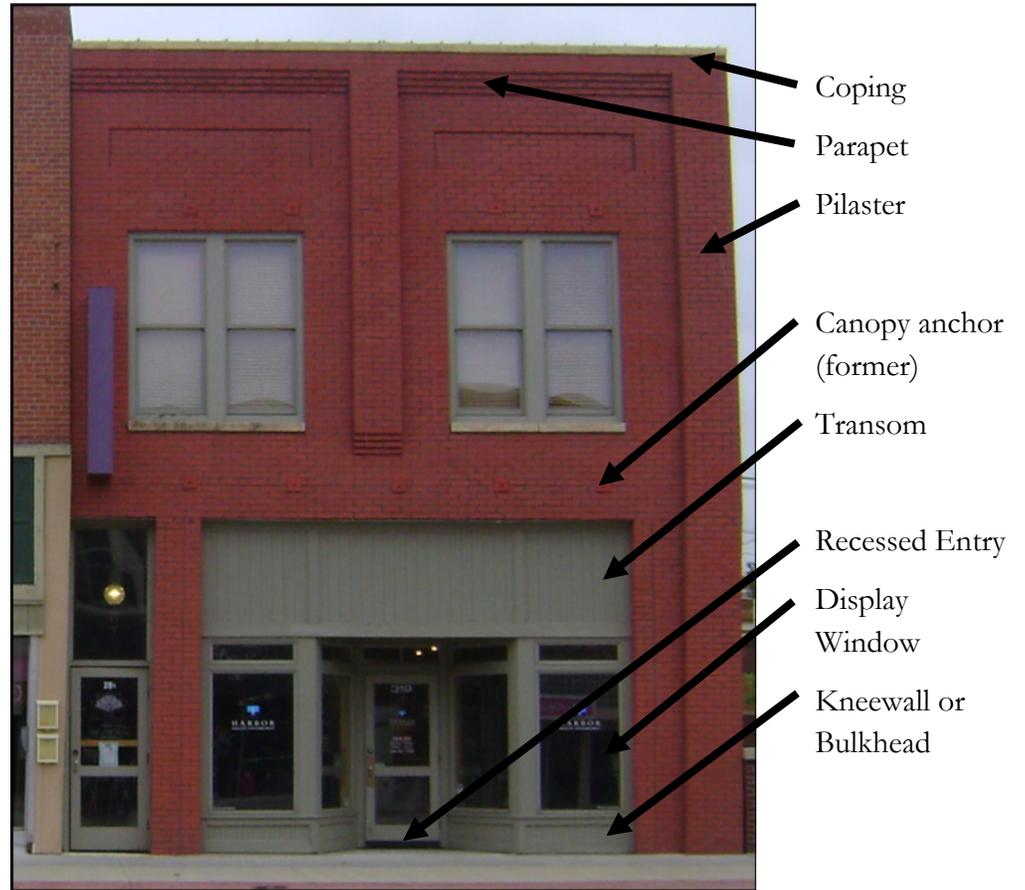
Figure 20: Annotated façade to show commercial building terminology. 319 East Grand (1911), Two-Part Commercial Block, Commercial Style [Rosin Preservation].

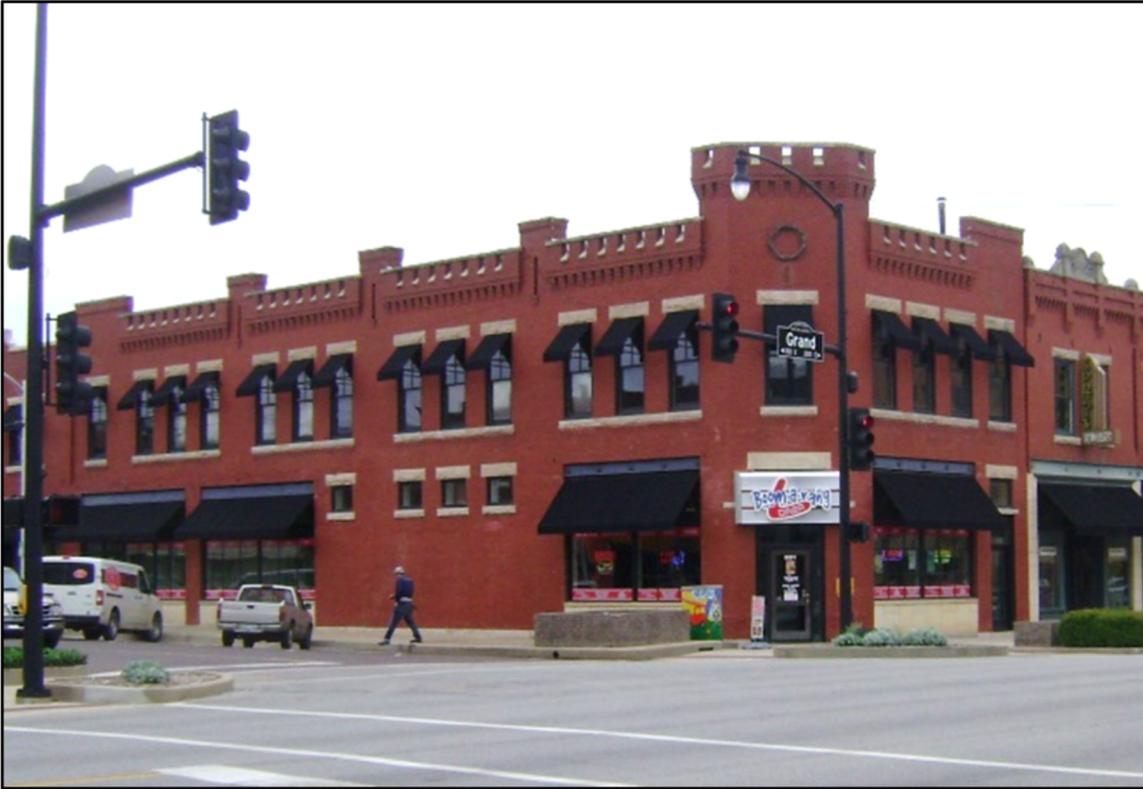
Figure 21: Pabst Building, 201 East Grand (1902). Brick is a character-defining feature of downtown Ponca City [Rosin Preservation].

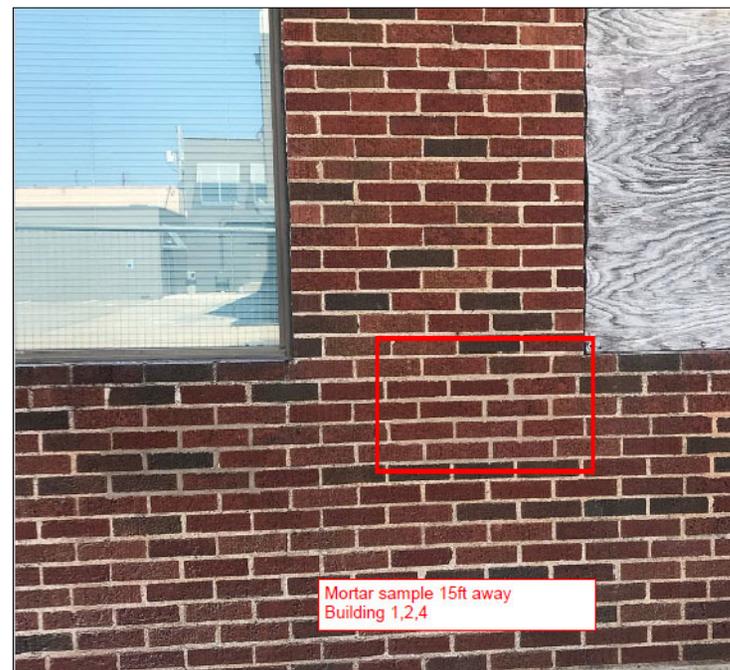
Figure 22: Midland Buildings, Tulsa. Example of a test patch of mortar [Rosin Preservation].

New mortar should match the physical properties of the historic mortar for aesthetic reasons. Replacement mortar should match the historic mortar in color, texture, aggregate, and joint profile (Figure 22). Many historic mortars have variations in aggregate size and colors, as well as a pigmented matrix. Replacement mortar that does not match the historic mortar will be an obvious alteration to the building facade. Historic joint profiles are important to match, as the change in profile alters the overall historic appearance of the building.

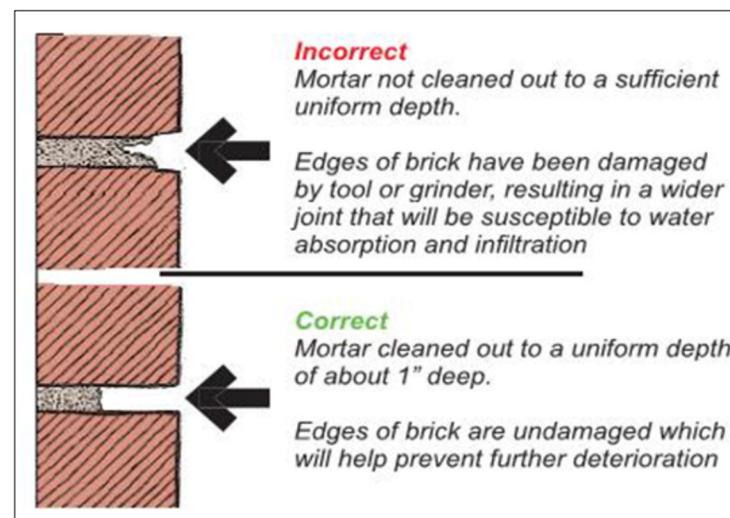
Figure 23: Image from *Architectural Graphic Standards*, Ninth Edition.

When removing existing mortar, it is important that removal is done by hand rather than with a power tool. Cutting out old mortar with power tools can cause irreparable damage to the brick and stone. (Figure 23)

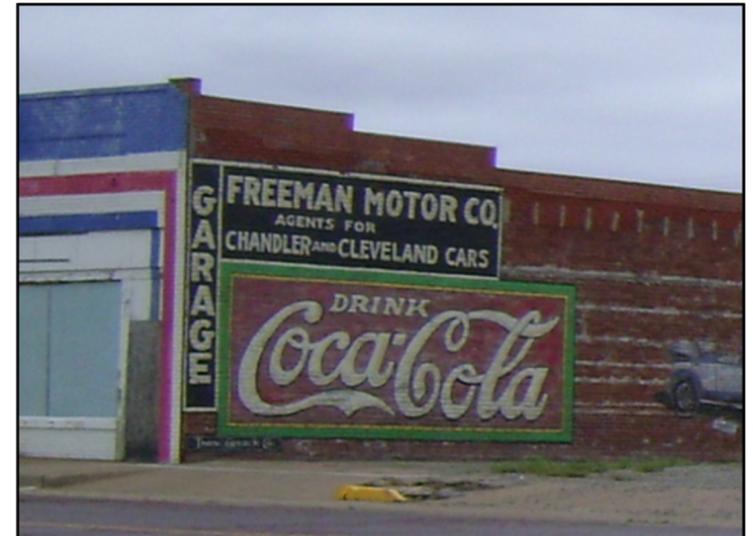
Figure 24: Mertz Building, 208 South 2nd Street (1925). Example of a historic painted sign in downtown Ponca City [Rosin Preservation].

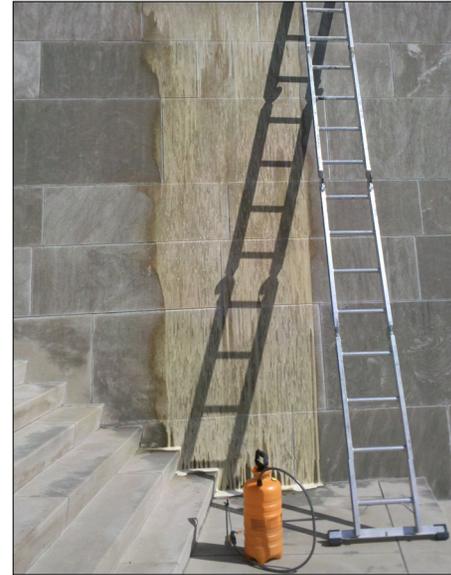
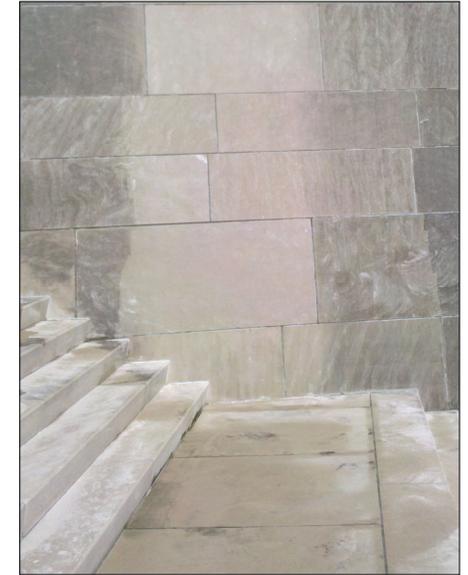
Figure 25: At left is a test patch of gentlest chemical cleaner and low-pressure water rinse. At right is the result of the test patch, showing clean masonry without the use of abrasive or high-power water [Rosin Preservation].

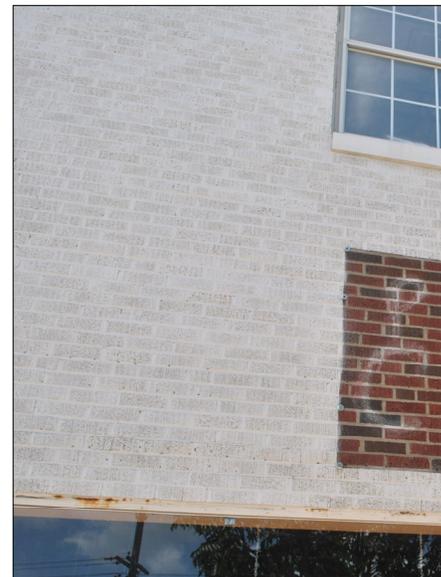
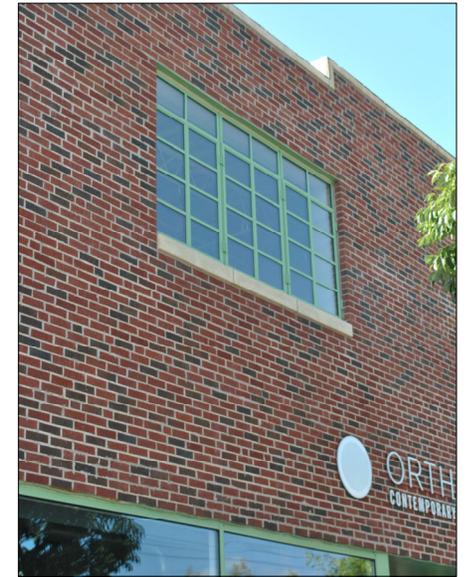
Figure 26: Anaya Building, Tulsa. At left is historic brick that had been painted. At right is after the paint had been removed using chemical remover [Rosin Preservation].

- Chemical paint remover is acceptable if it is applied correctly (Figure 26).
- Repair damaged masonry, in-kind, prior to repainting.
- Prepare building surface for new masonry paint, per manufacturer's instructions. This will help new paint adhere to the building and prolong the life of the paint.

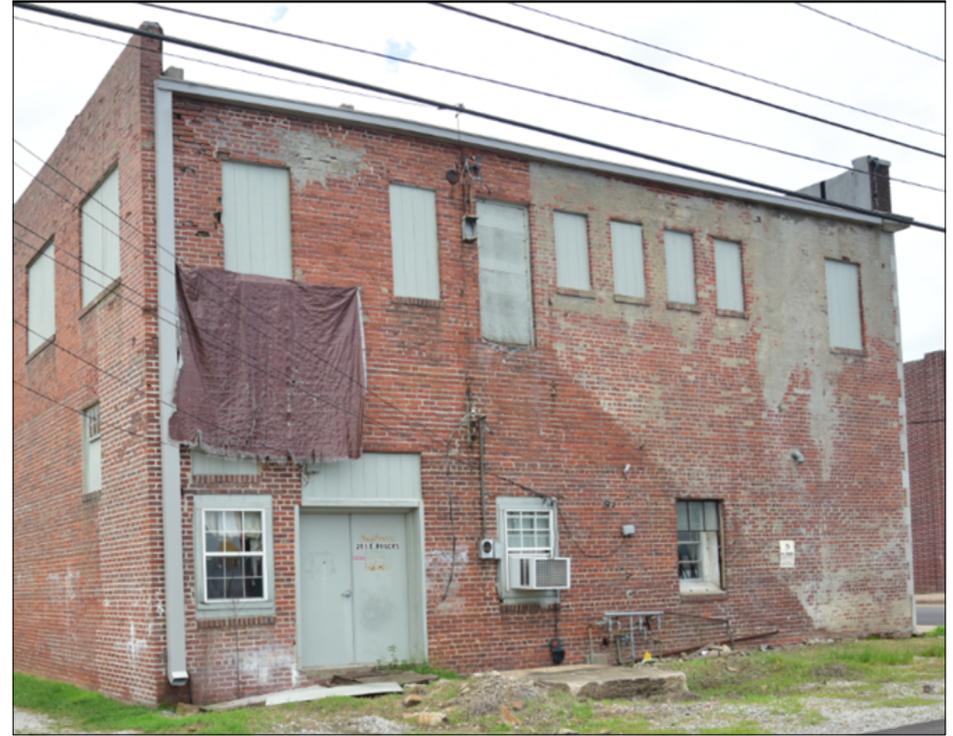
Figure 27: 201 East Rogers Boulevard, Skiatook. Example of masonry that has been improperly repointed [Rosin Preservation].

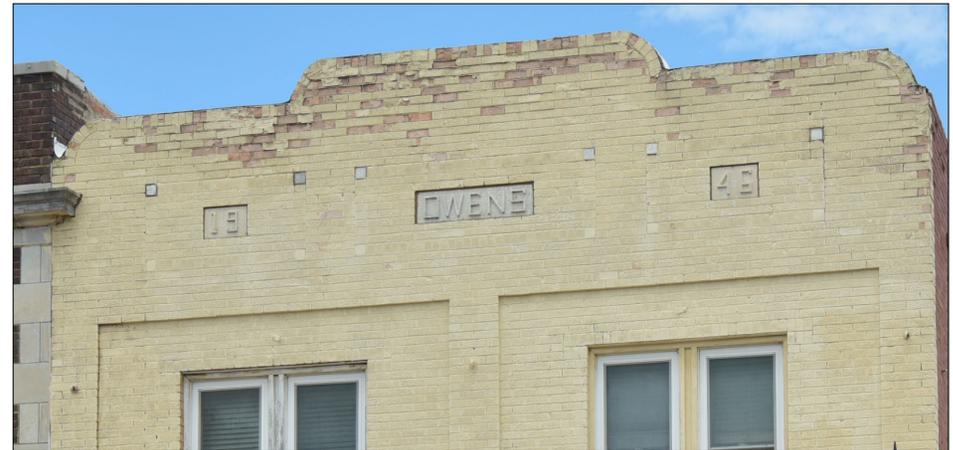
Figure 28: 205 East Rogers Boulevard, Skiatook. Example of painted brick that is spalling due to trapped water [Rosin Preservation].

If masonry is to be painted, care must be taken to choose a ‘breathable’ paint product for masonry. When a latex or ‘skin forming’ paint is used, it traps water behind the paint layer and causes permanent damage to the masonry (spalling, cracking and deterioration). Generally, a paint of coating with a permeability of 10 perms or more is considered permeable. Elastomeric paints or coatings are not appropriate.

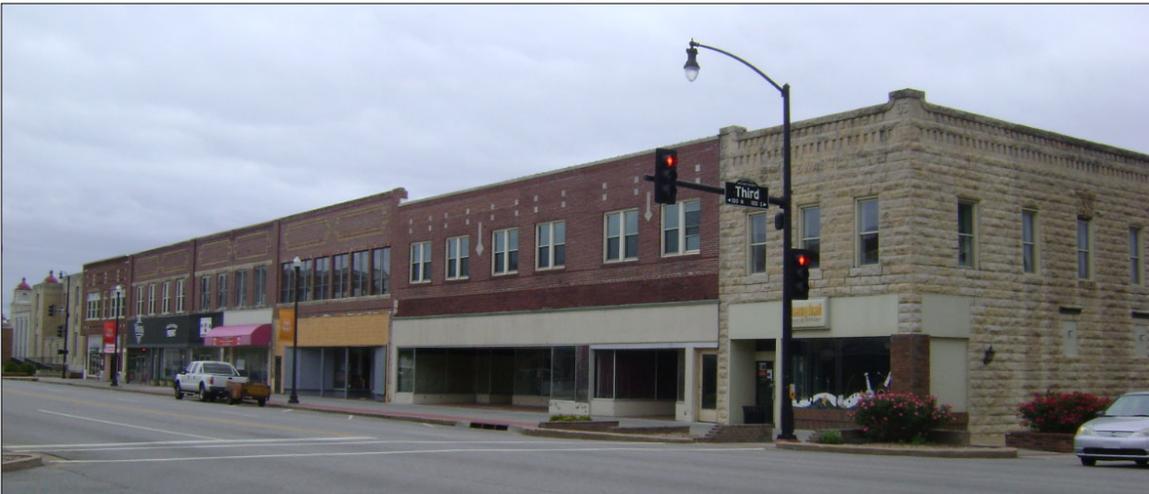
Figure 29: 300 Block of East Grand Avenue, showing downtown's characteristic masonry [Rosin Preservation].

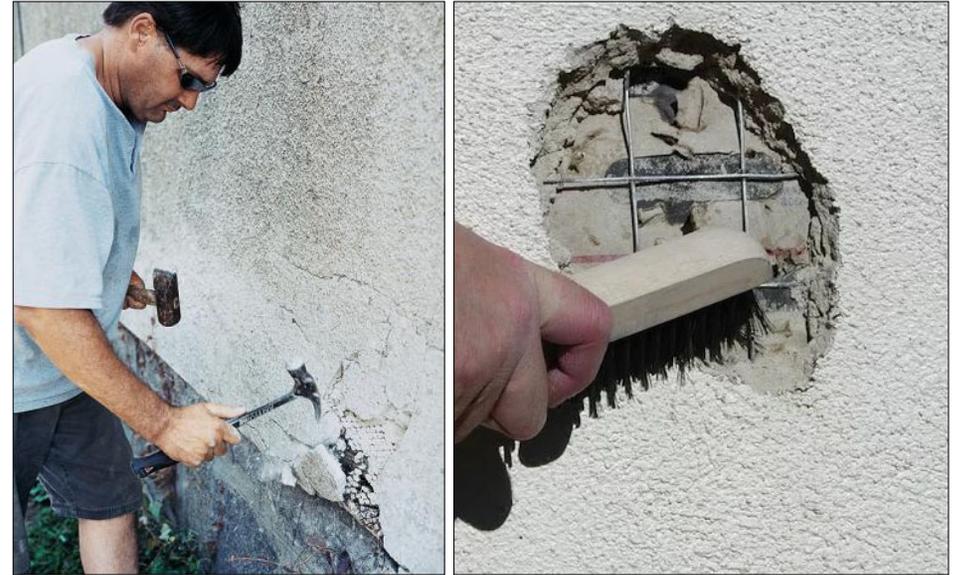
Figure 31: Carefully remove loose and damaged plaster [At left: thisoldhouse.com; at right: bobvila.com].

- Test historic stucco for its composition before new stucco mixture is made.
- Always remove loose stucco and repair damaged areas before painting (Figure 31). Patched areas should match original stucco as closely as possible in appearance and texture (Figure 32).
- Seal hairline cracks with a thin slurry coat (consisting of finish coat ingredients), paint, or whitewash.
- Carefully remove stucco that was inappropriately applied to exterior facades that masks historic features of the building (Figure 33)).
- Install only historically appropriate authentic stucco.
- Clean airborne dirt from stucco using water at a pressure less than 300 -400 psi and a soft natural bristle brush; non-ionic detergents may also be used. Algae, mold, and metallic stains may be removed using poultices and appropriate solvents; test a small section before complete cleaning.

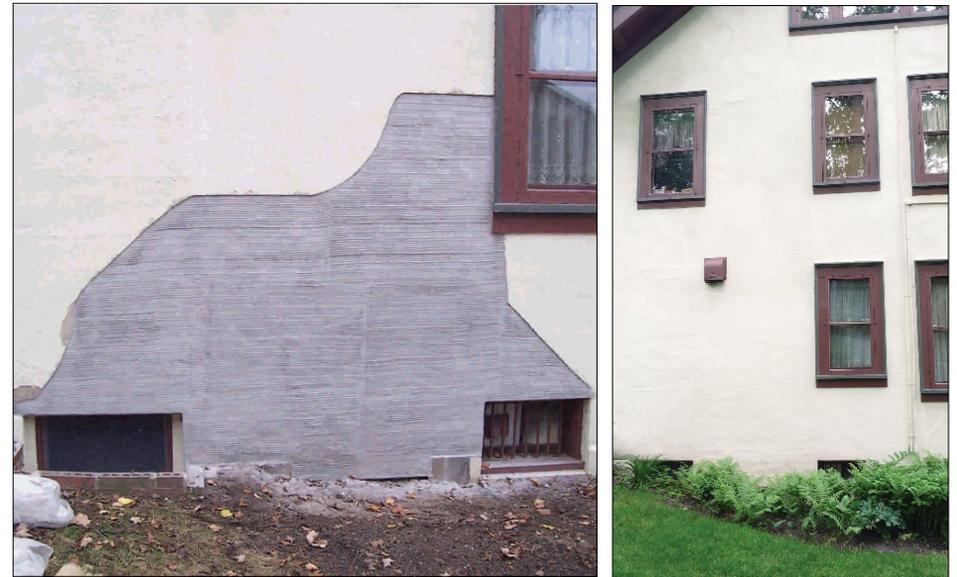
Figure 32: Scratch coat applied to patched area; wall after patching is finished [oldhouseonline.com].

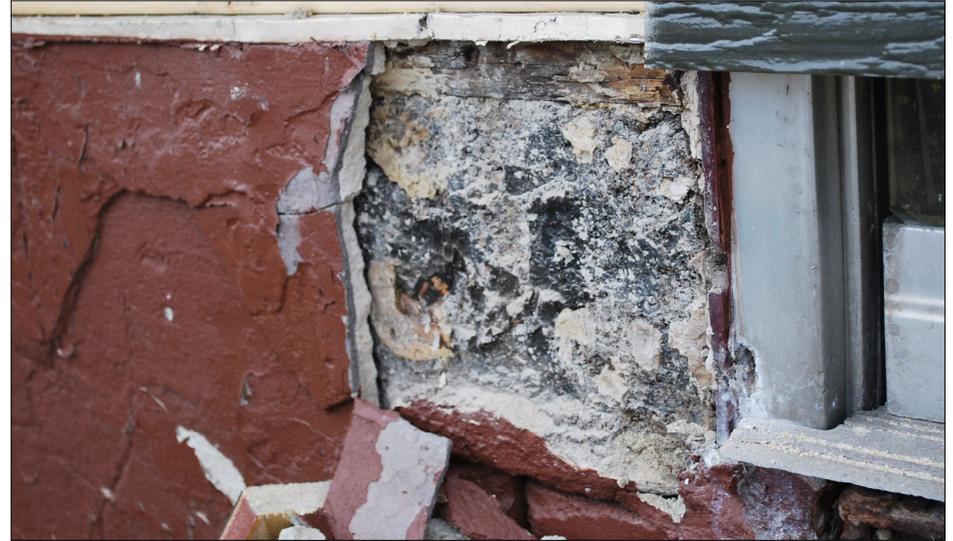
Figure 33: Example of delaminating non-historic stucco installed over historic masonry foundation. Stucco was damaged by water infiltration [Rosin Preservation].

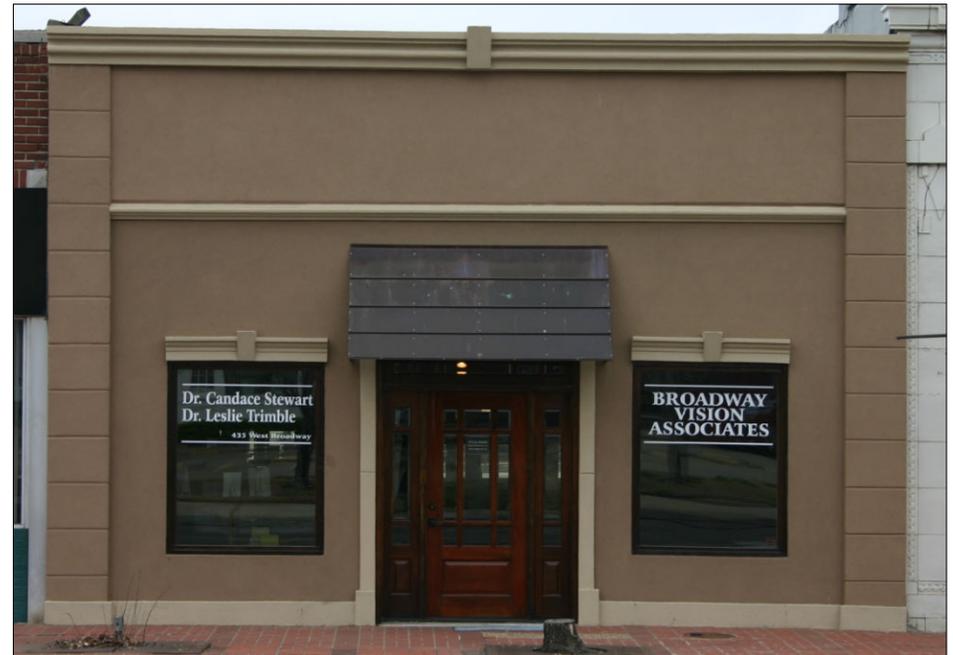
Figure 34: 435 West Broadway, Muskogee, EIFS applied to historic brick building. Not Recommended [Rosin Preservation].

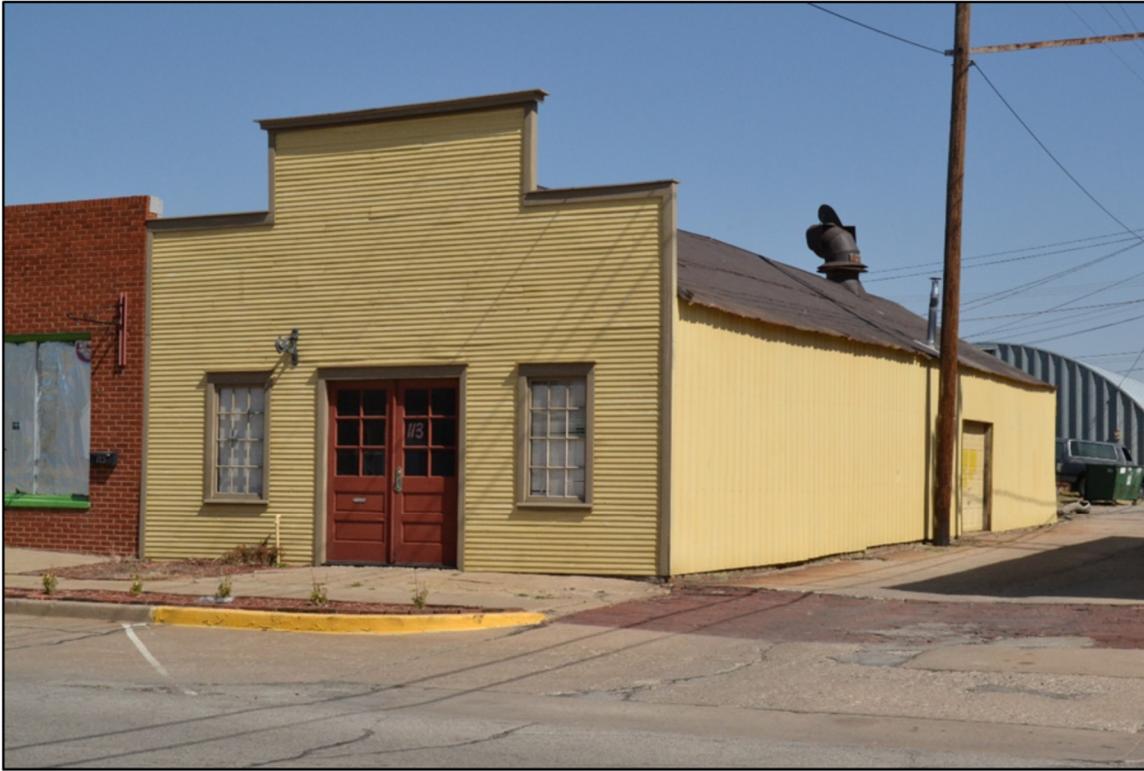
Figure 35: Wegner Planing Mill, 113 North Pine (ca 1895). Historic façade has wood siding [2018 Survey].

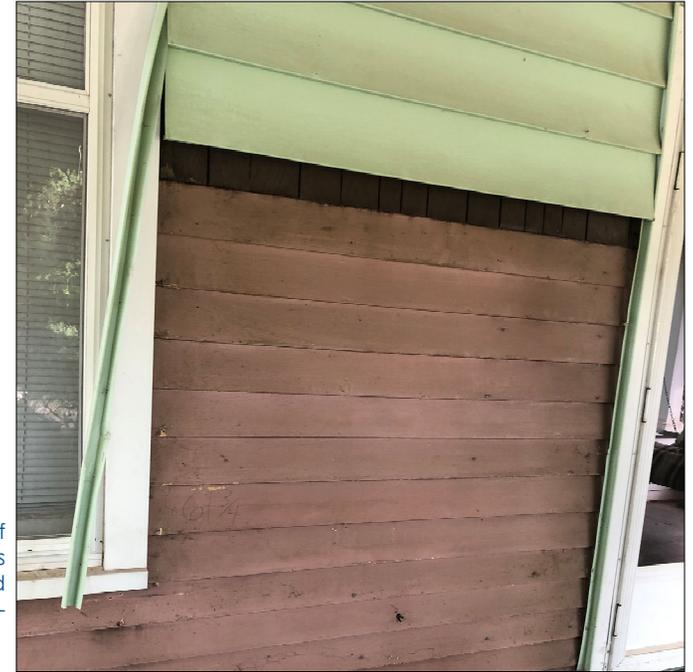
Figure 36: Removal of vinyl siding reveals historic wood clapboard beneath [Rosin Preservation].

- Remove existing inappropriate siding that covers original, historic materials (Figure 36).
- It is always advisable to paint, rather than replace wood with another material (Figure 37).
- Deteriorated siding or decorative elements should be patched or consolidated in place or replaced with in-kind materials.
- When replacing materials, match the overall dimension, thickness, profile, scale, and finish of the original material.
- Preparation of wood surfaces and proper priming will add longevity to paint applications.
- Utilize high quality exterior paint.
- Paint stripping should be done by the gentlest means possible.

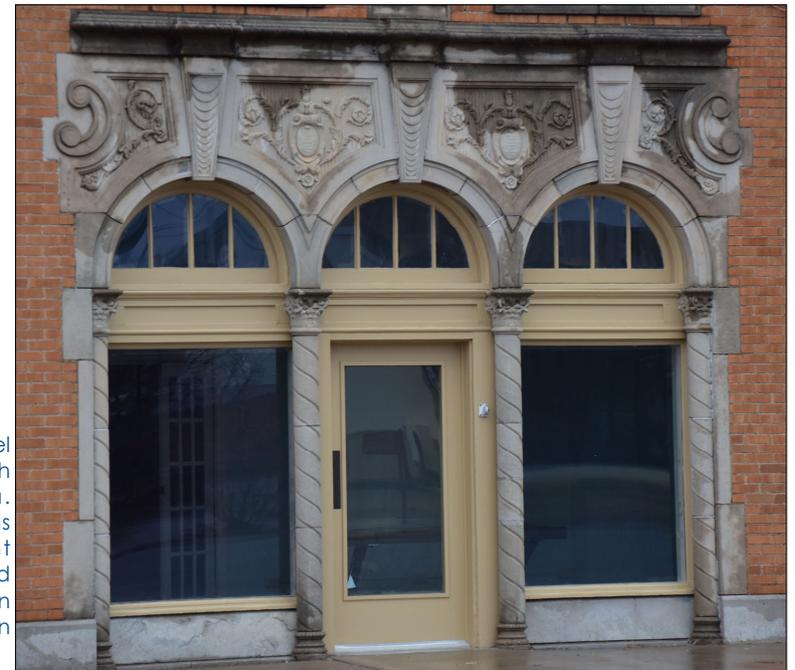
Figure 37: Hotel Vinita, 201 South Wilson, Vinita. Wood transoms and storefront windows repainted rather than replaced [Rosin Preservation].

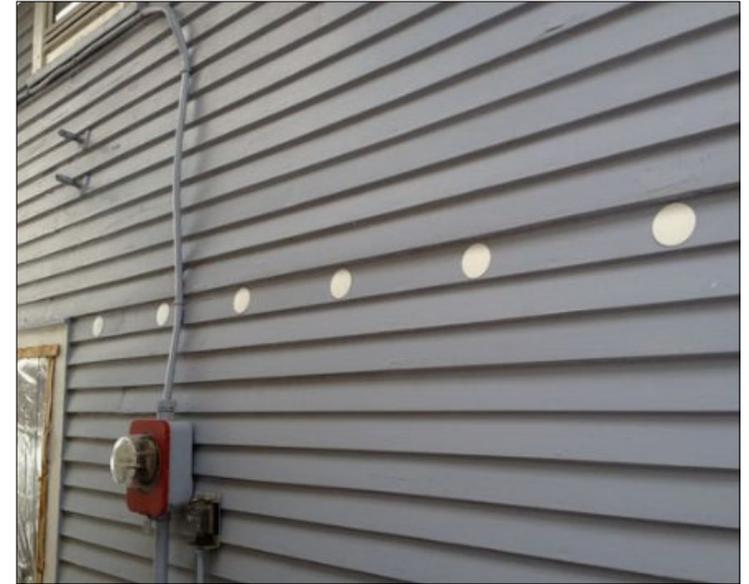
Figure 38: Visible plugs after the installation of blown-in insulation detract from the building aesthetic [insulationtoledo.com].

- Applying new paint to existing deteriorated paint that has cracked or has too many layers.
- Installing aluminum, vinyl, or other synthetic siding to cover original, historic wood siding or building elements.
- Installing blown-in insulation from the exterior, which necessitates the use of visible plugs (Figure 38).
- Staining or leaving wood unfinished (Figure 39).
- Removing historic, character-defining elements from a building.

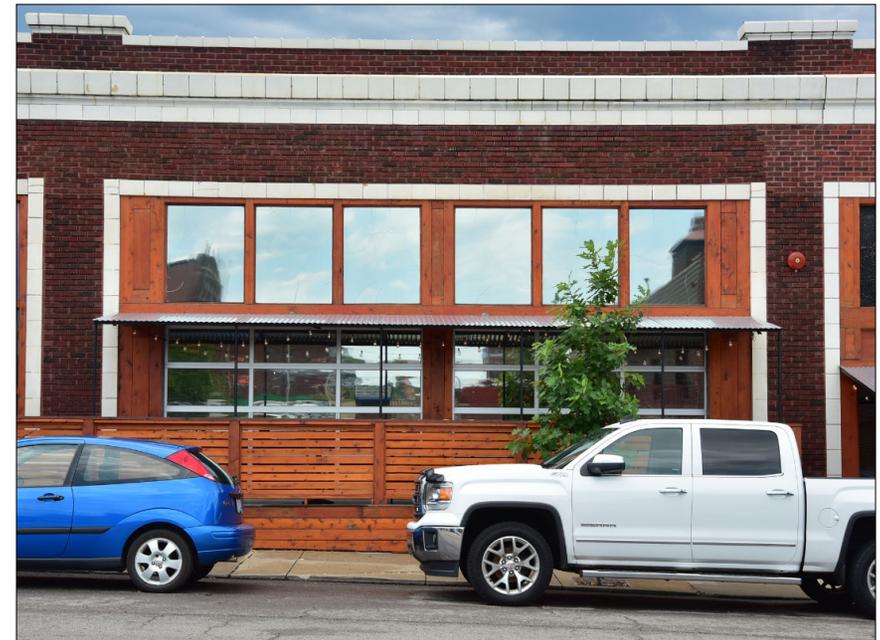
Figure 39: Example of unpainted wood in a downtown historic building [Rosin Preservation].

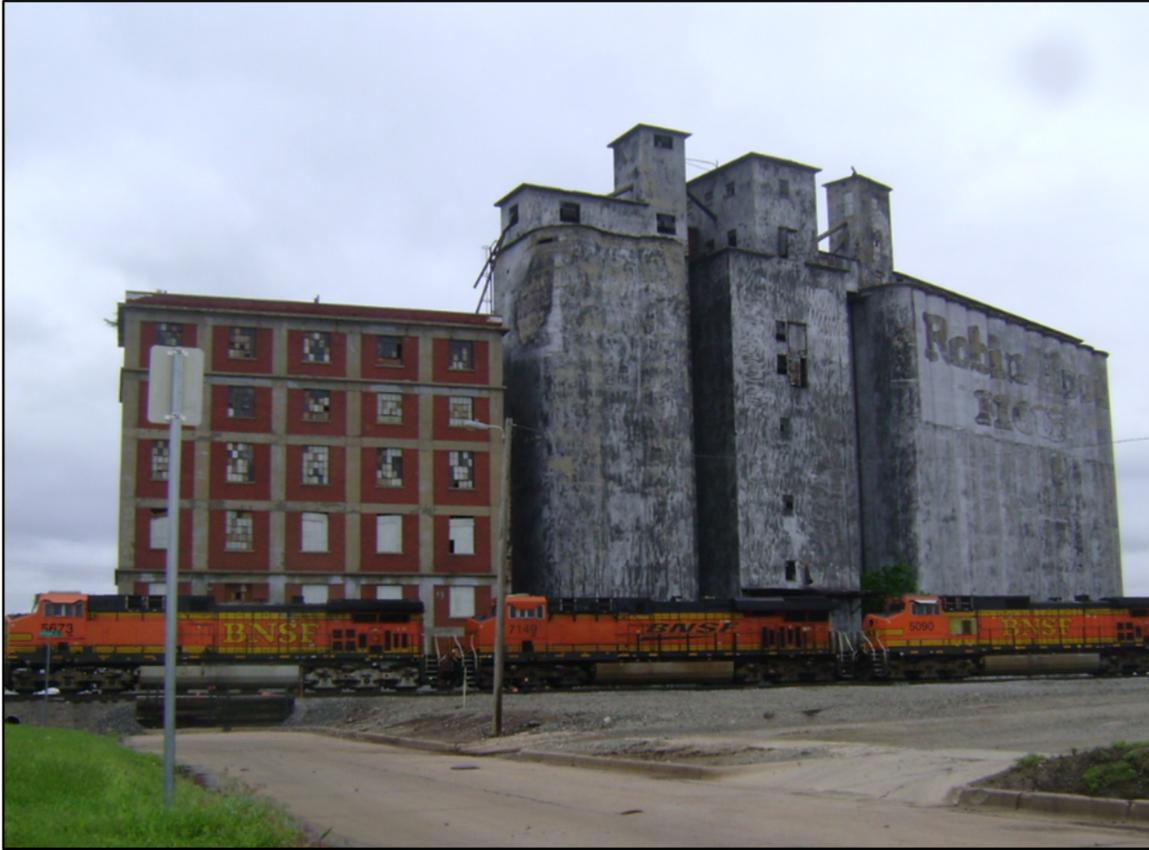
Figure 40: Ponca City Mill Company, 114 West Central Avenue. Historic elevators are made of reinforced concrete [Rosin Preservation].

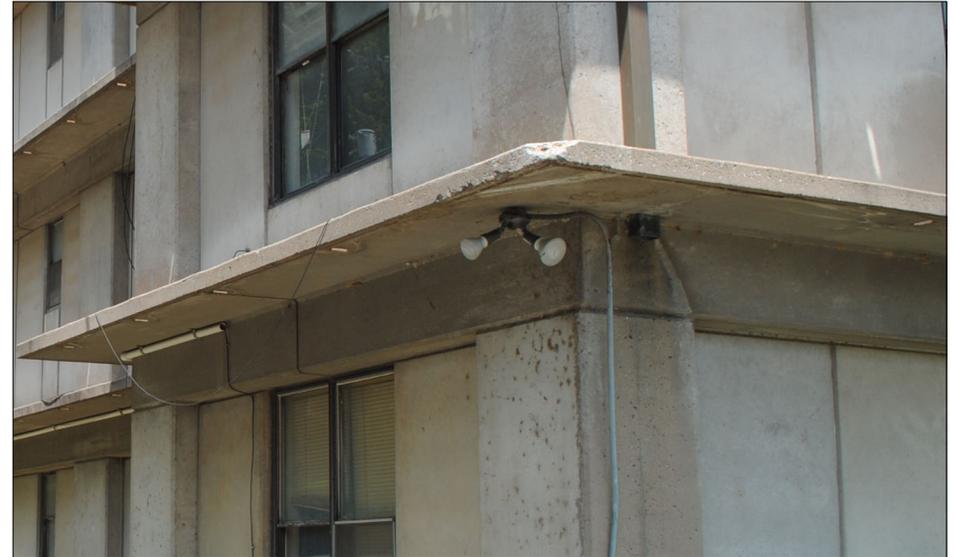
Figure 41: It is recommended to identify the cause of deterioration before patching concrete [Rosin Preservation].

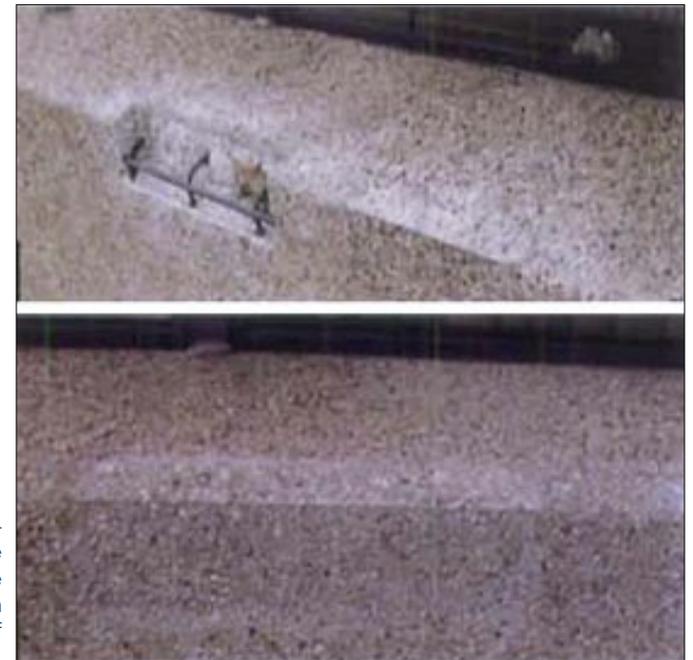
Figure 42: Match aggregate, color, and texture of historic concrete when creating a patch [NPS, Preservation Brief 15].
