HISTORIC DOWNTOWN PONCA CITY DESIGN GUIDELINES MANUAL

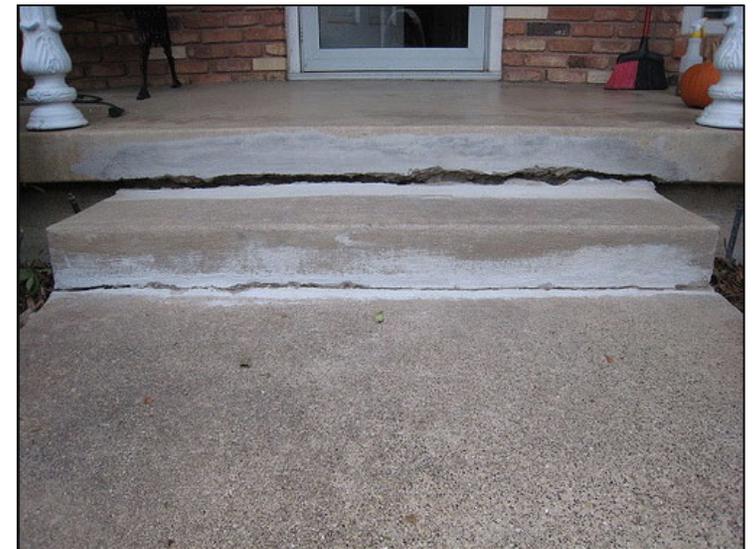
Figure 44: Example of poorly matched concrete applied without the underlying problem being remedied [erincouvert.wordpress.com].

- Using abrasive cleaning techniques such as sandblasting (Figure 43).
- Patching concrete without addressing the source of deterioration (Figure 44).
- Using a patching material that does not match the original concrete. Make sure new concrete will bond properly with existing concrete in order to avoid water penetration and further damage (Figure 44).
- Using caulk to patch cracks.
- Painting previously unpainted historic concrete.
- Installing modern synthetic stucco systems.

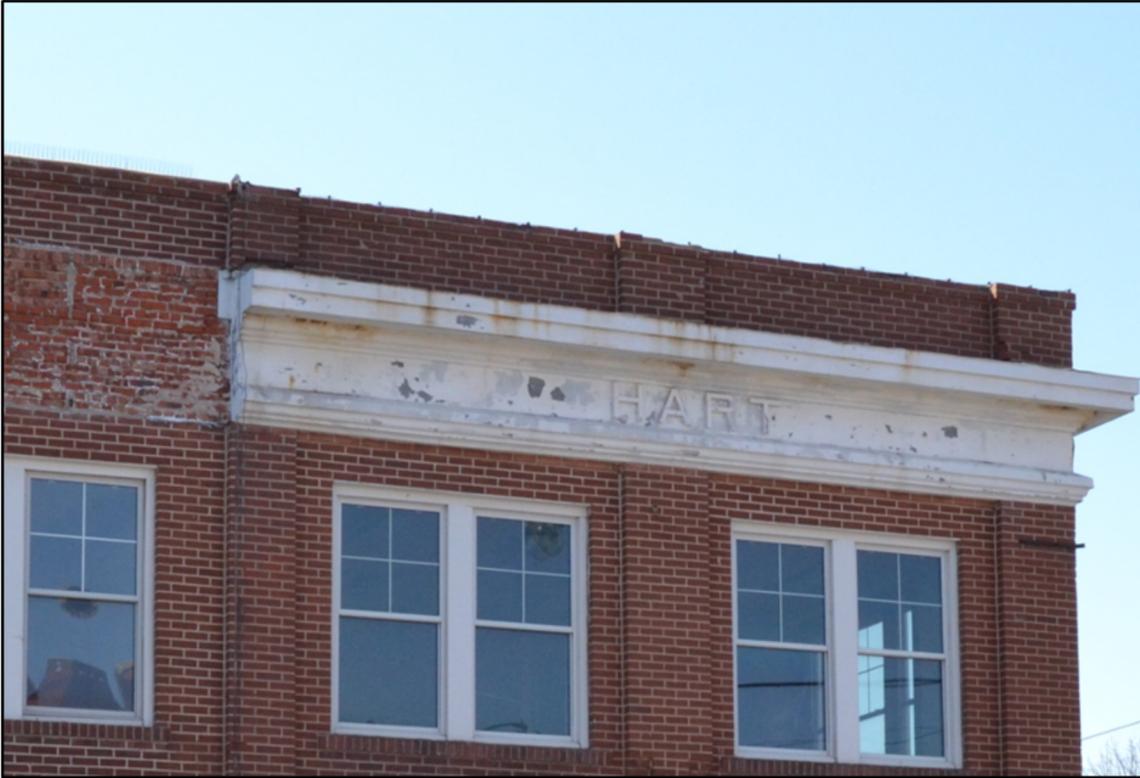
Figure 45: Hart Building, 200 East Grand Avenue (1928). Metal cornice [Rosin Preservation].

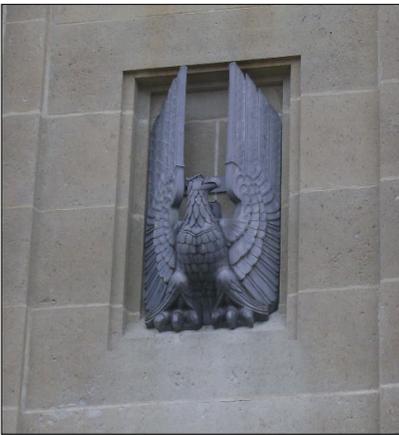
Figure 46: Detail of bronze eagle on the Federal Building, 402 East Grand Avenue (1935) [Rosin Preservation].

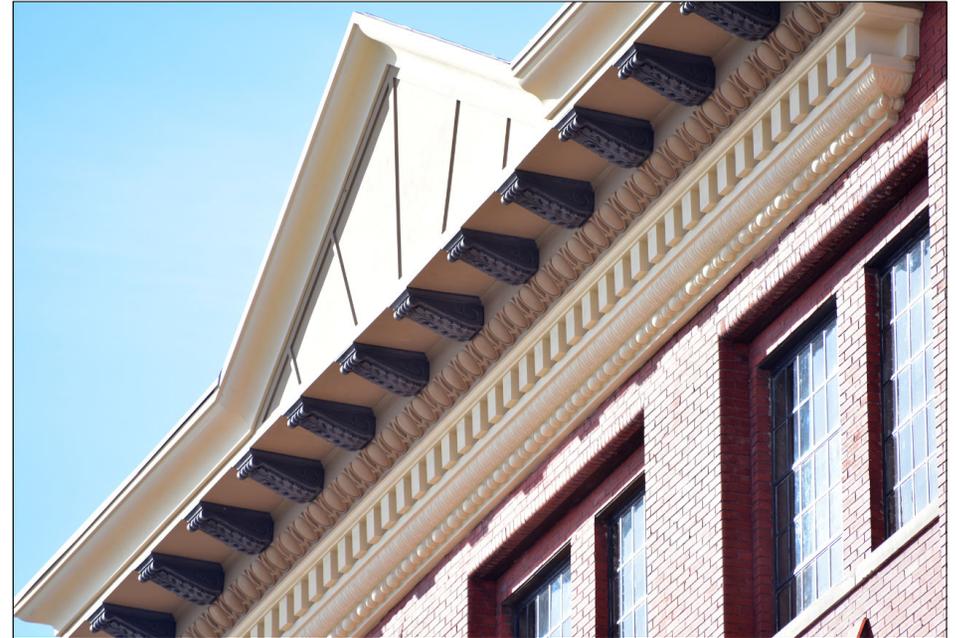
Figure 47: This metal cornice was repaired and partially reconstructed [Rosin Preservation].

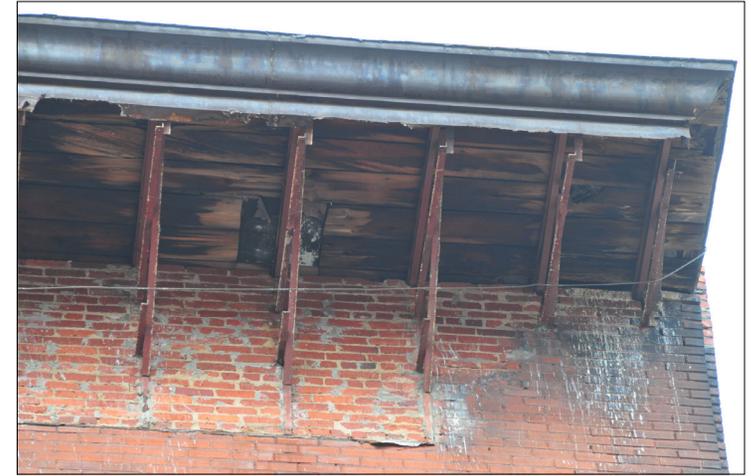
Figure 49: This metal cornice was left exposed to the weather and water infiltration caused the loss of a portion of it [Rosin Preservation].

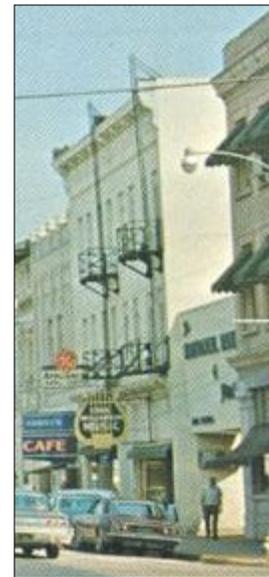
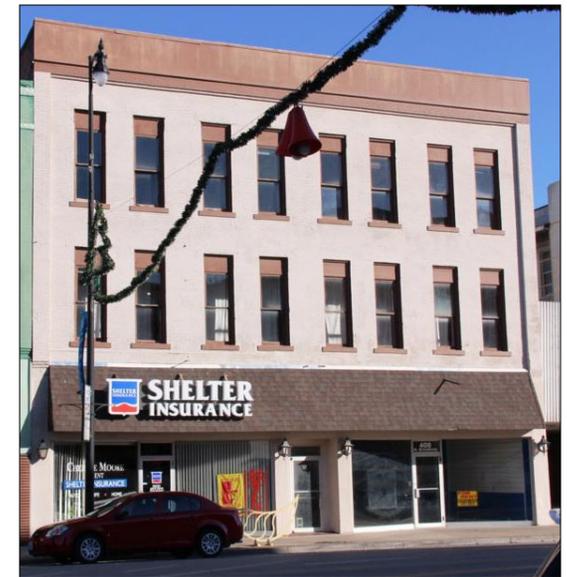
Figure 50: This building's historic metal cornice was removed in the 1970s [khri.org].

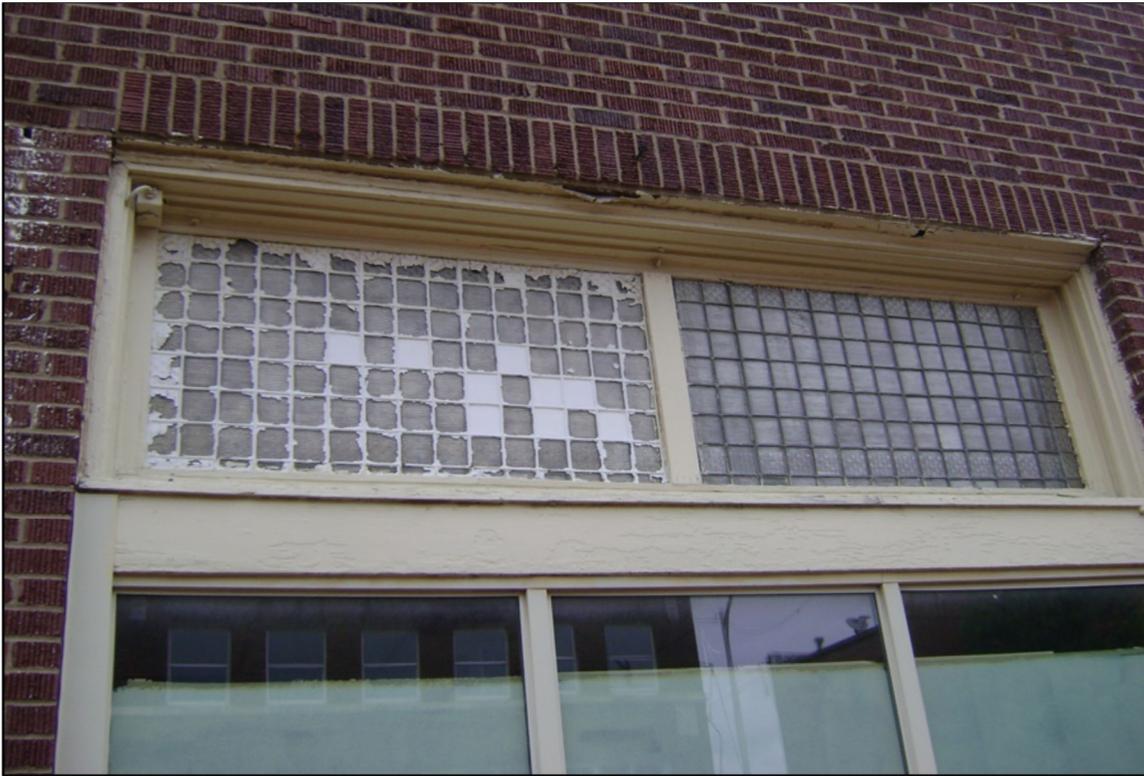
Figure 51: Lahoma Hotel, 214 East Cleveland Avenue (1930). Prismatic glass tile transom on north elevation of building with paint being removed [Rosin Preservation].

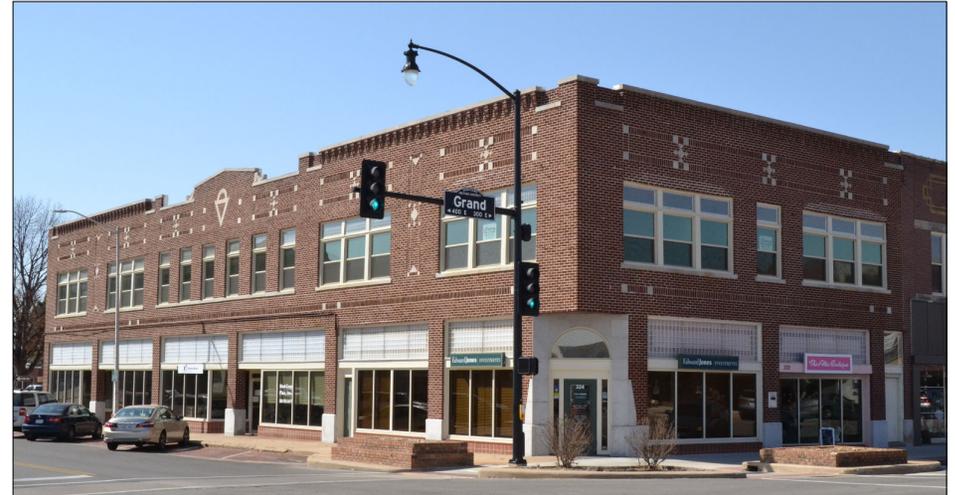
Figure 52: Marland Building, 322-324 East Grand Avenue (1928). Prismatic glass tile transoms have been retained and left uncovered [2018 Survey].

- Remove paint and uncover prismatic glass transoms (Figure 51).
- Deteriorated prismatic glass transoms should be repaired using historic tiles.
- Retain and uncover historic glass tiles (Figure 52).
- When tiles are missing, transoms should be replicated using glass that matches closely the appearance of historic tiles.
- Employ a craftsman familiar with repairing prismatic transoms or stained glass.
- Add structural rigidity to bowed transoms using reinforcing bars on the interior of the transom.
- Install interior storms if efficiency is a concern (Figure 53).
- Use a waterproof grout between the tiles and coming.

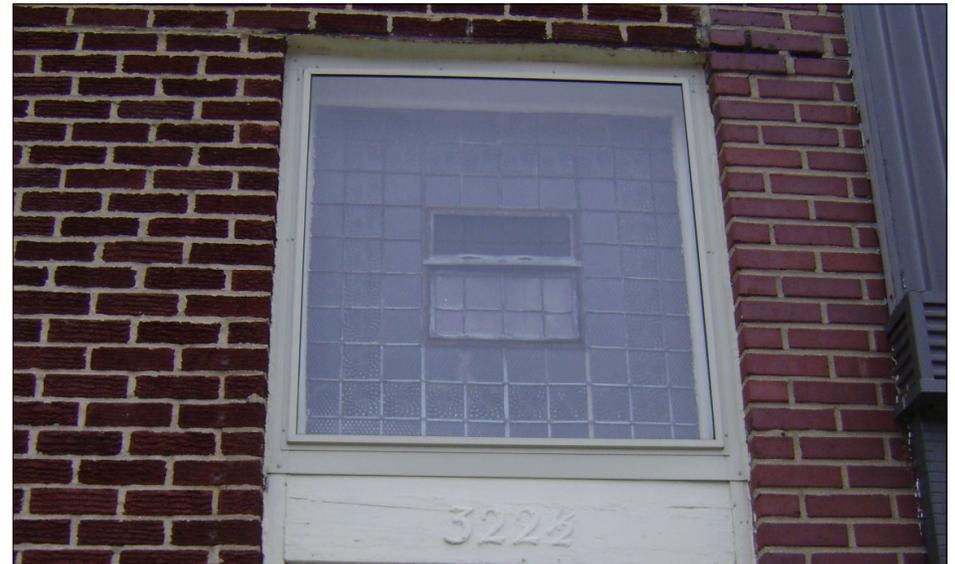
Figure 53: Marland Building, 322-324 East Grand Avenue (1928). Although recommended to be installed on the interior for aesthetics, storm windows can add to the efficiency of these windows [Rosin Preservation].

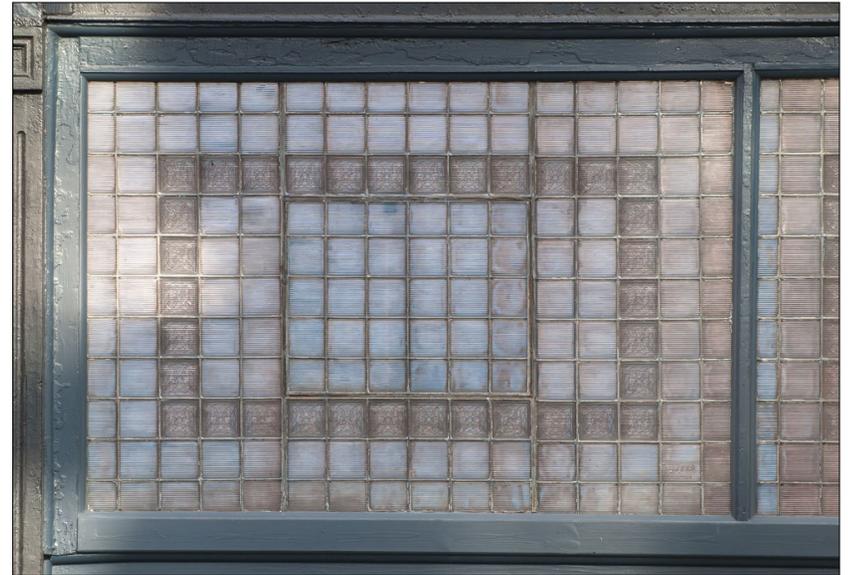
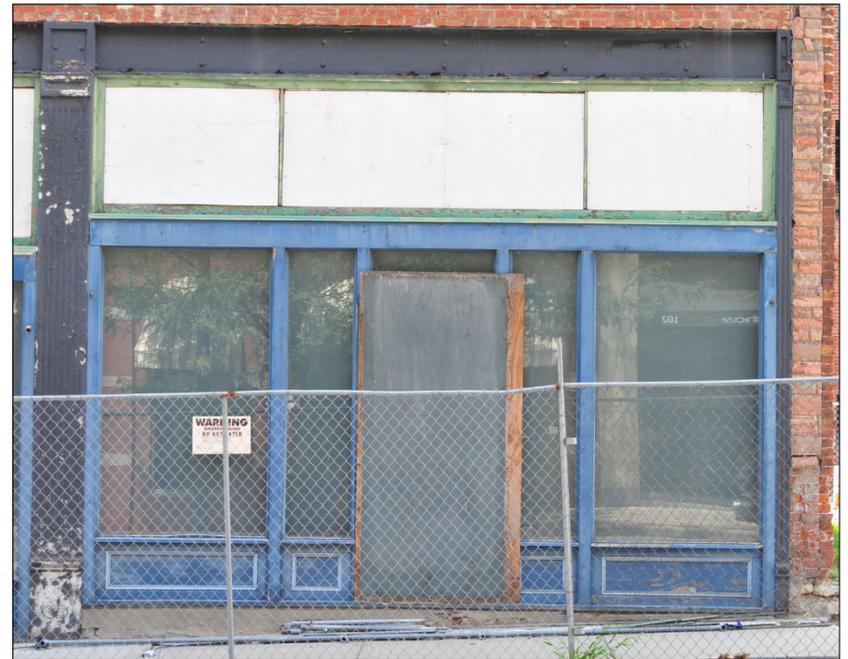
Figure 54: The historic prismatic glass transoms seen in top photo were covered by plywood. This is not a recommended treatment [Rosin Preservation].

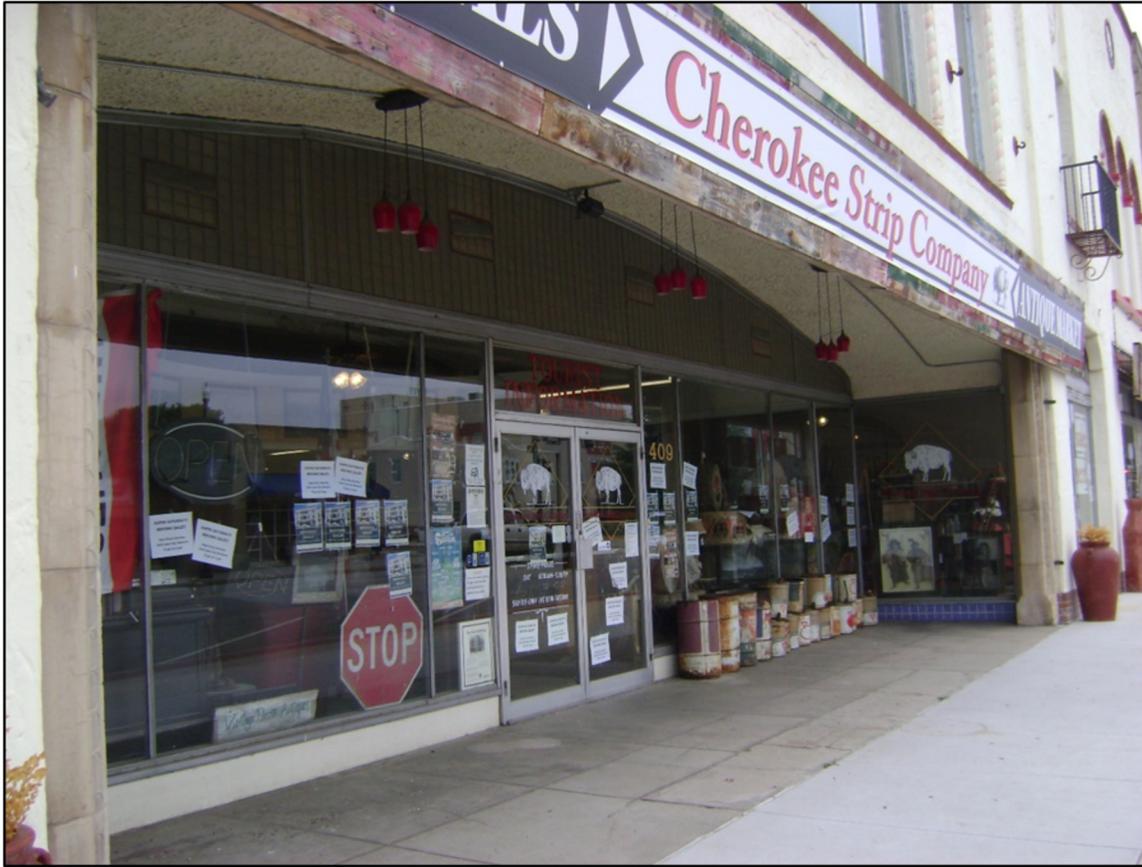
Figure 55: 409 East Grand Avenue (1927). Historically recessed storefront with prismatic glass transom and mid-century storefront [Rosin Preservation].

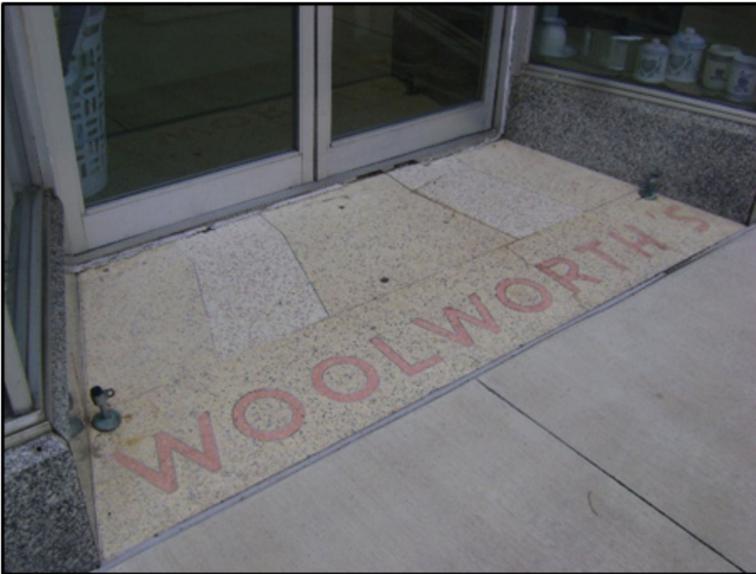
Figure 56: Harter Building, 207 East Grand Avenue (1924). Historic mid-century recessed storefront with designed entry floor [Rosin Preservation].

- Historic entry floors should be retained (Figure 56).
- Character-defining features of the storefront should be identified and retained (Figure 57)
- Historic materials should be retained, and new materials should be compatible with the district (Figures 58 & 59).

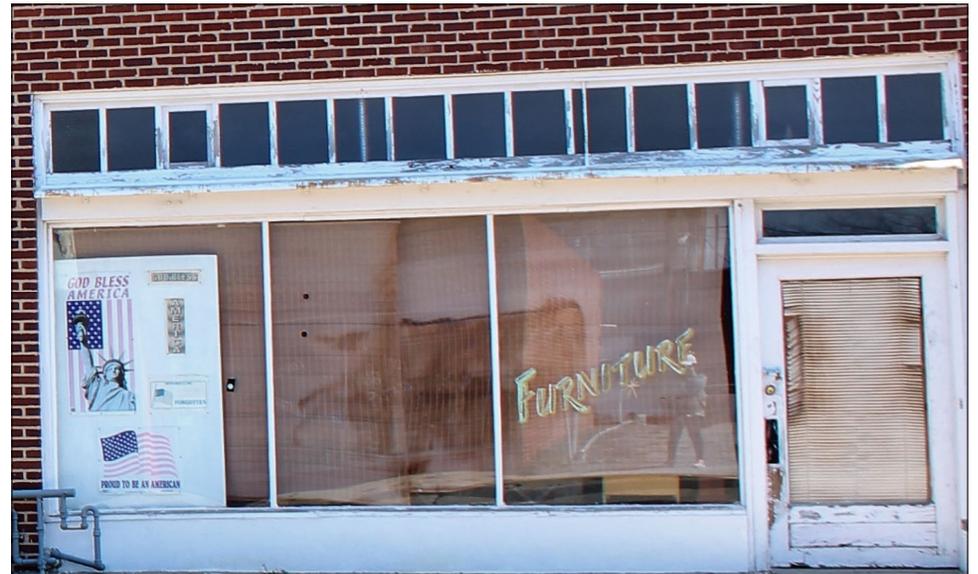
Figure 57: 211 North 3rd Street (1925). Historic transom and entry door from 1925 and mid-century display windows [Rosin Preservation].

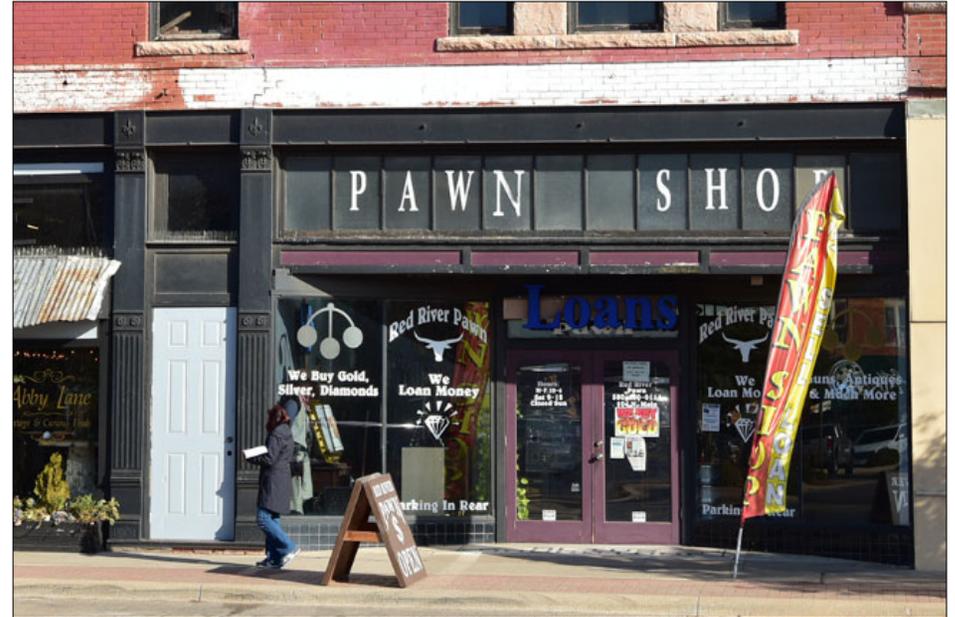
Figure 58: 104 North Main Street, Altus. This is an example of a storefront that retains its older historic transom and cast iron pilasters with a historic mid-century storefront system [Rosin Preservation].

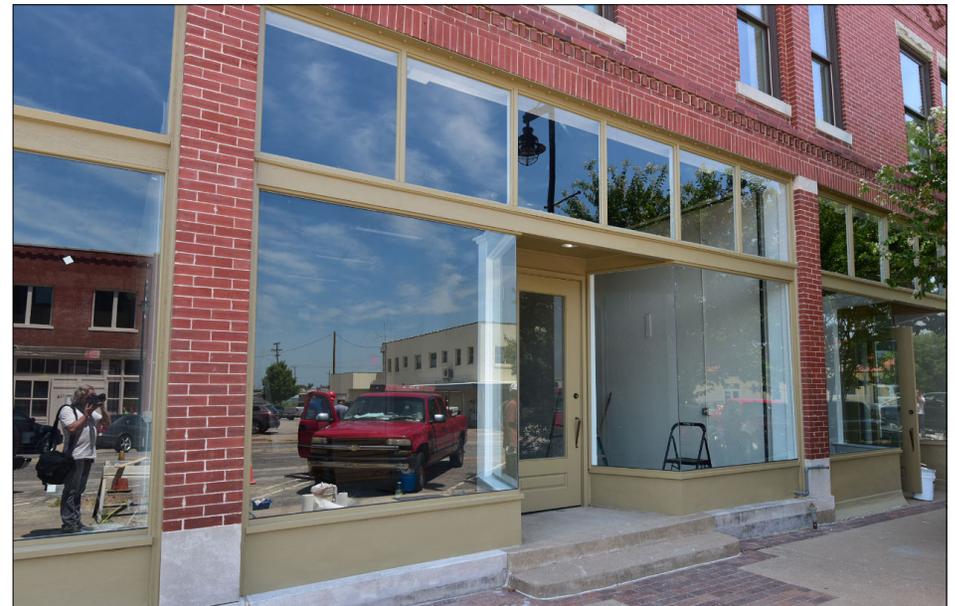
Figure 59: 119-125 West 2nd Street, Bartlesville. This is an example of a new storefront that is compatible with the historic building [Rosin Preservation].

- Storefronts should have kneewalls, display glass, door, and transom (Figure 59).
- Inset entries should be retained.
- Replace infilled storefront with historically appropriate storefront.

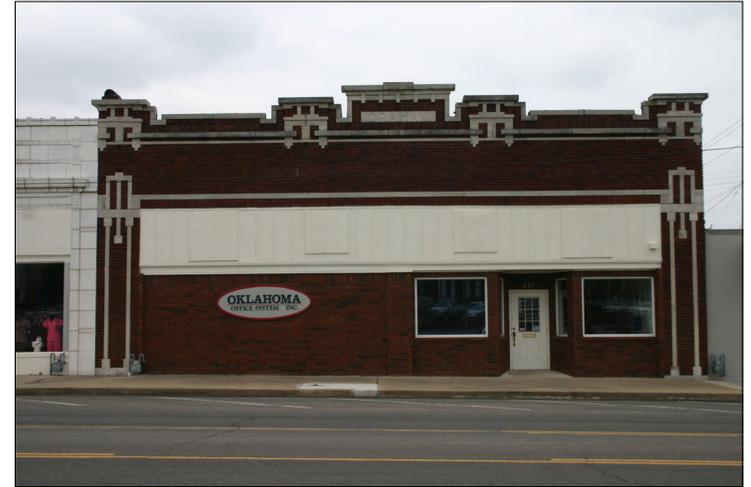
Figure 60: 531 West Broadway, Muskogee. The left storefront has been completely infilled, the right storefront is of an incompatible design, and the transom is covered. These are not recommended treatments [Rosin Preservation].

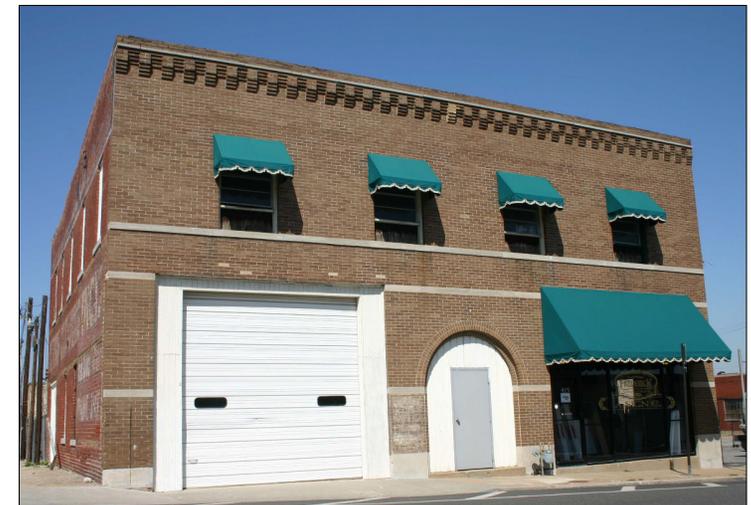
Figure 61: 417 East 3rd Street, Tulsa. The left historic storefront was removed and replaced with a garage door. This is not recommended treatment [Rosin Preservation].

- Reducing the size of windows.
- Infilling storefronts (Figure 60).
- Installing residential or security-style doors or windows in storefronts.
- Installing garage doors where there were none historically (Figure 61).
- Recessing unless storefronts were historically.
- Dividing display windows into smaller panes unless historic.
- Using tinted or mirrored glass.
- Replacing a historic but not original storefront with a storefront whose design is based on conjecture.
- Adding ramps to the front of the building.

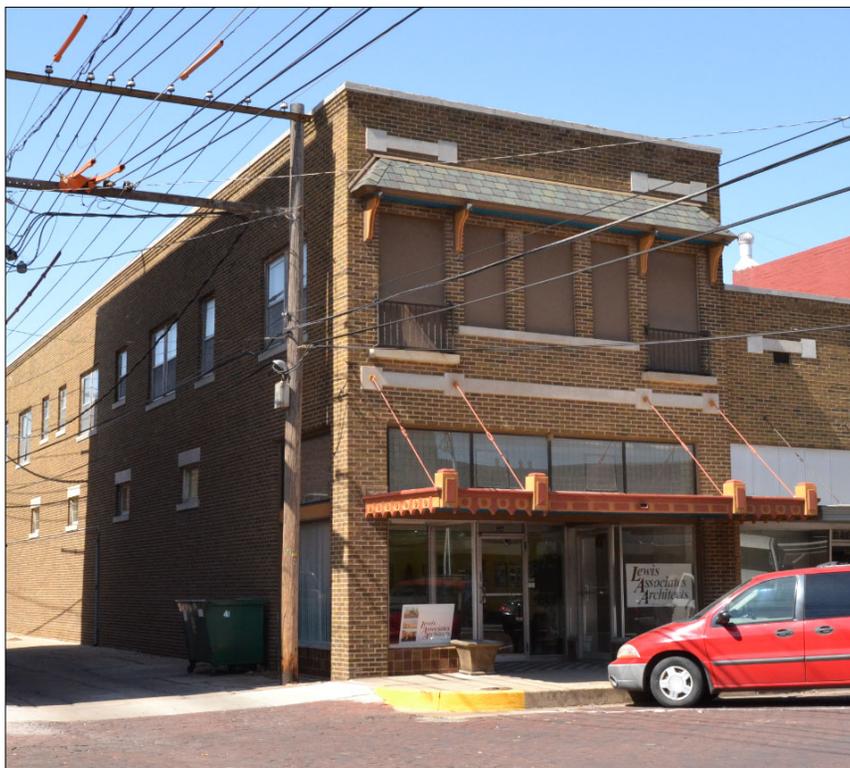
Figure 63: Ponca City Distributing Company Building, 112 North 3rd Street, has an example of a historic canopy within downtown [2018 Survey].

- Retain and rehabilitate extant historic awnings, canopies, and marquees (Figure 63).
- Awnings and canopies should be installed within a single opening (Figure 64).

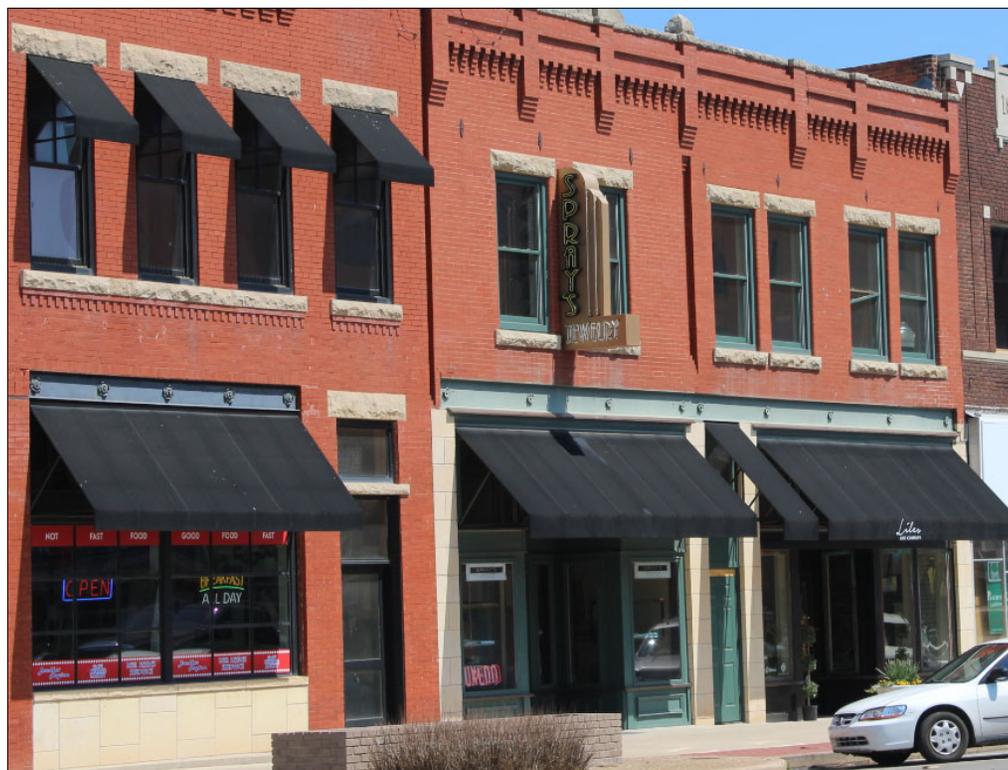
Figure 64: 201 to 205 East Grand Avenue with examples of awnings [2018 Survey].

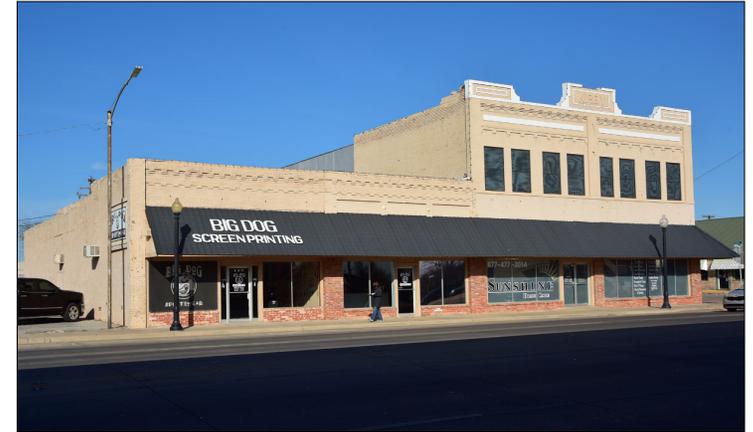
Figure 65: 117 East Broadway, Altus. Example of a new awning spanning more than one storefront. This is not a recommended treatment [Rosin Preservation].

- Spanning more than one storefront, window, or door with a single awning or canopy (Figure 65).
- Extending vertically into the upper façade (Figure 66).
- Installing on buildings that cannot structurally support them or whose façade design does not allow for the installation without character-defining features being covered.
- Covering character-defining features of a building with a new awning.
- Using shingles, plastic, vinyl, or other similar synthetic materials.
- Removing historic awnings, canopies, or marquees unless they are deteriorated beyond repair.
- Using curved, vaulted, open grid, or semi-spherical awnings.
- Using backlit or illuminated awnings and canopies .

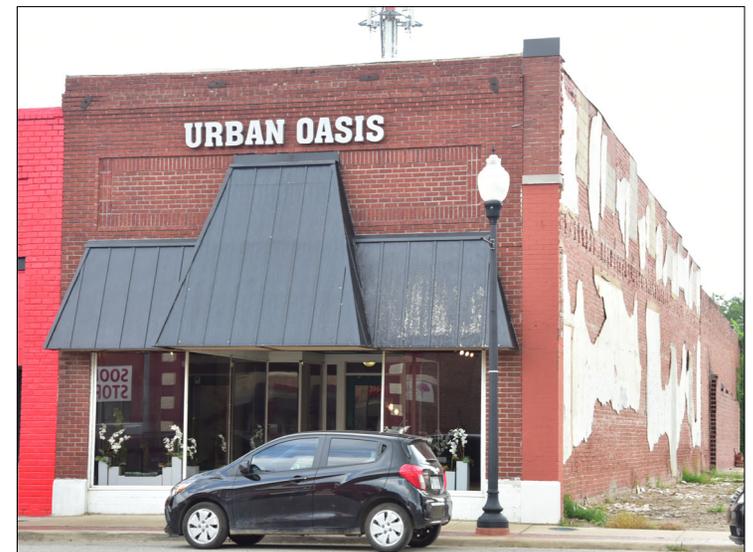
Figure 66: 206 East Rogers Boulevard, Skiatook, showing a metal awning that extends into the upper façade. This is not a recommended treatment [Rosin Preservation].

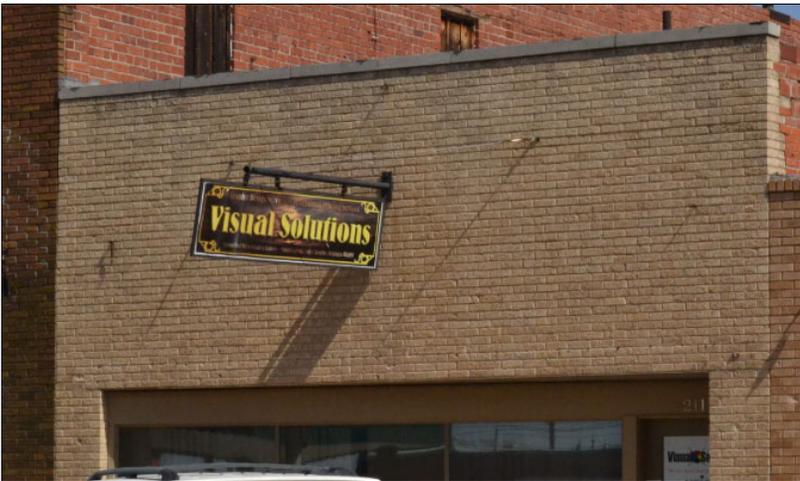
Figure 69: Example of projecting signage on 211 North 2nd Street [2018 Survey]

- Historic signage will be retained and preserved in place (Figure 68).
- Reproduction signage will be allowed if there is documentation to support its reintroduction to downtown.
- New signage will be primarily pedestrian oriented.
- Signs will be of durable materials such as wood, metal, glass, painted acrylic.
- Neon signs may be used if they are appropriate to the building.
- The size of the signage should be subordinate and proportional to the building on which it is located.
- Signs will be mounted so as not to obscure character-defining features. Hardware will be installed within mortar joints and not into masonry units.
- Signage can be applied to new awnings (Figure 69).
- Signs can be hanging, wall-mounted, projecting, awning, or above transom (Figure 74).

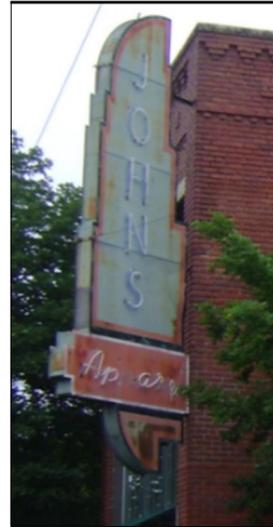
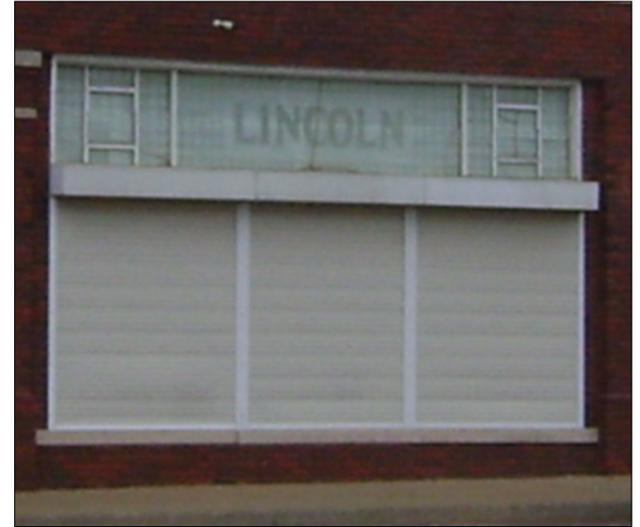
Figure 68: Examples of historic signage in downtown Ponca City that has been retained [Rosin Preservation]

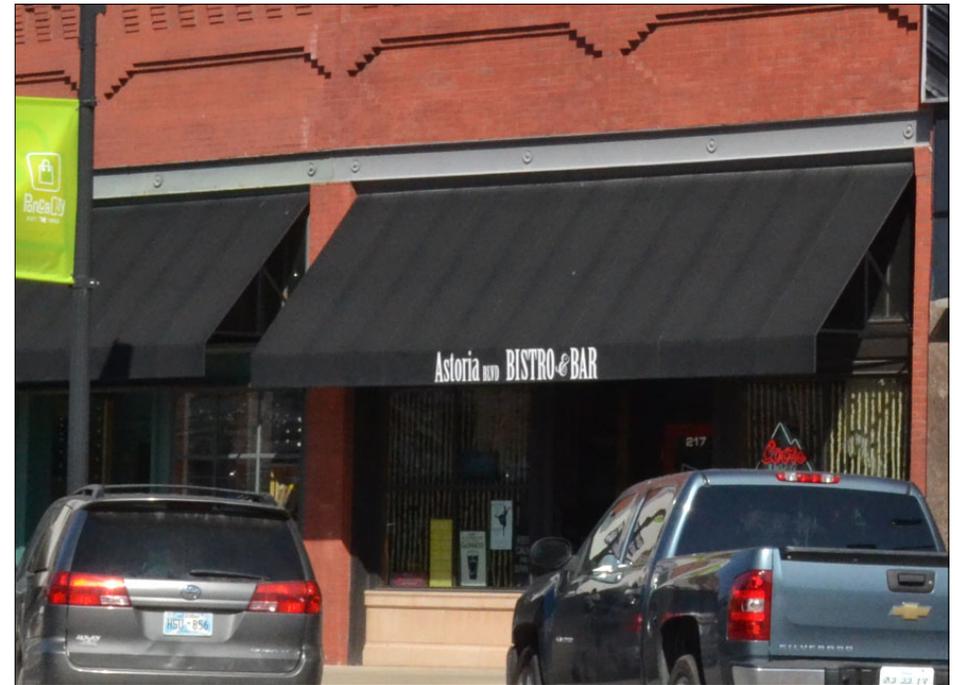
Figure 70: Example of signage applied to new awning at 207 East Grand Avenue [Rosin Preservation]

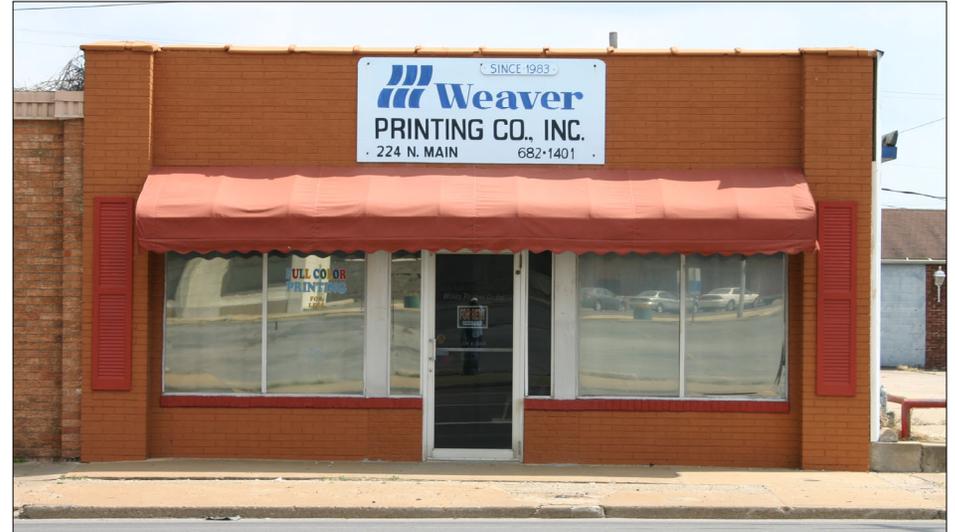
Figure 71: 224 North Main Street, Muskogee, with a handmade sign. [Rosin Preservation]

- Installing banners, handmade, or other temporary signage (Figure 71).
- Installing illuminated plastic signs. (Figure 72)
- Installing signs to obscure transoms or other character-defining features (Figure 73).
- Installing signs that mostly or completely obscure the storefront display windows.
- Removing historic signage, even if that business is no longer located at the building.

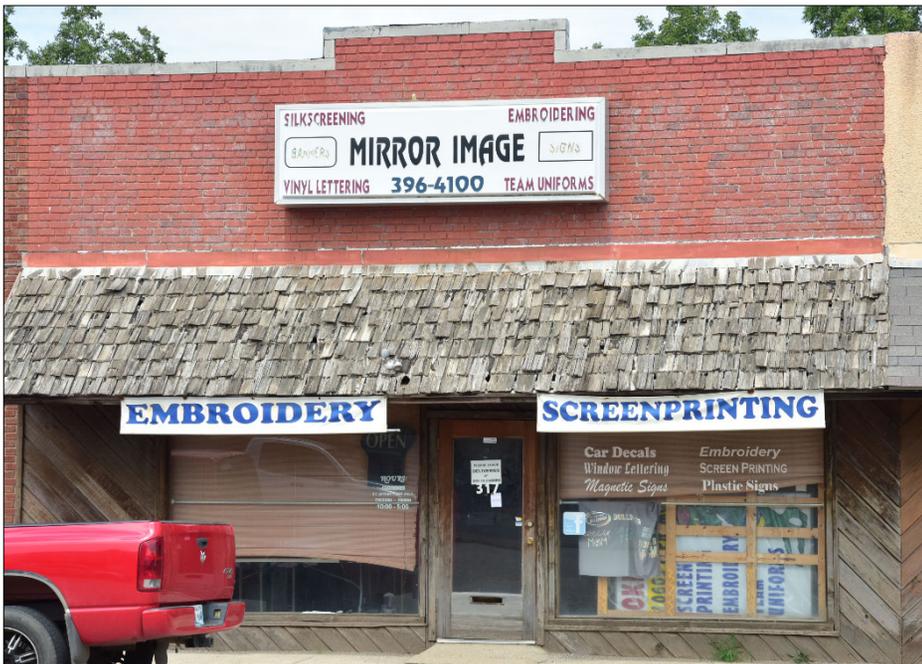
Figure 72: 317 East Rogers Boulevard, Skiatook, handmade and illuminated signs [Rosin Preservation].

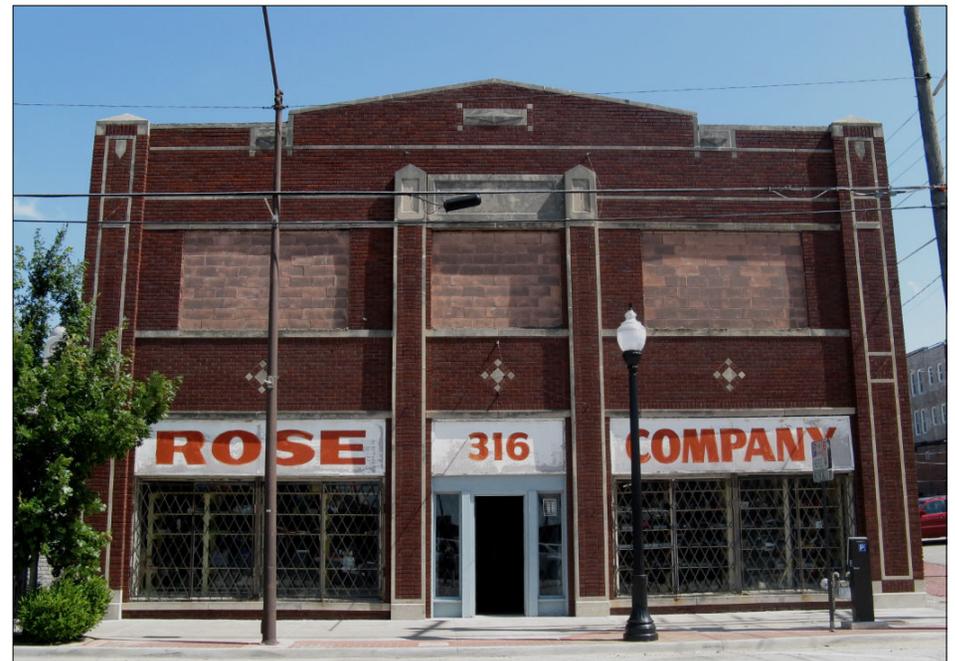
Figure 73: 316 East 2nd Avenue, Tulsa, with a handmade sign obscuring the building's historic transom. [Rosin Preservation]

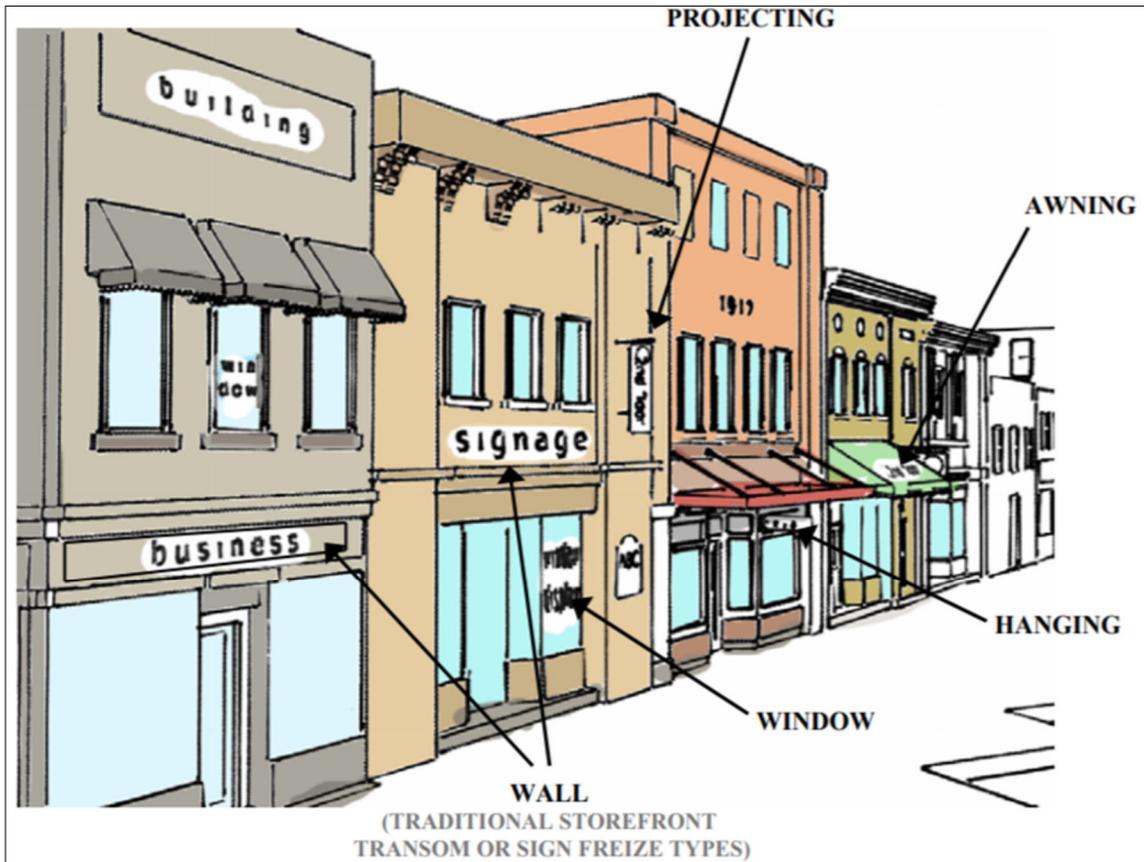
Figure 74: Types of recommended signage and placement [City of Lawrence, Kansas]

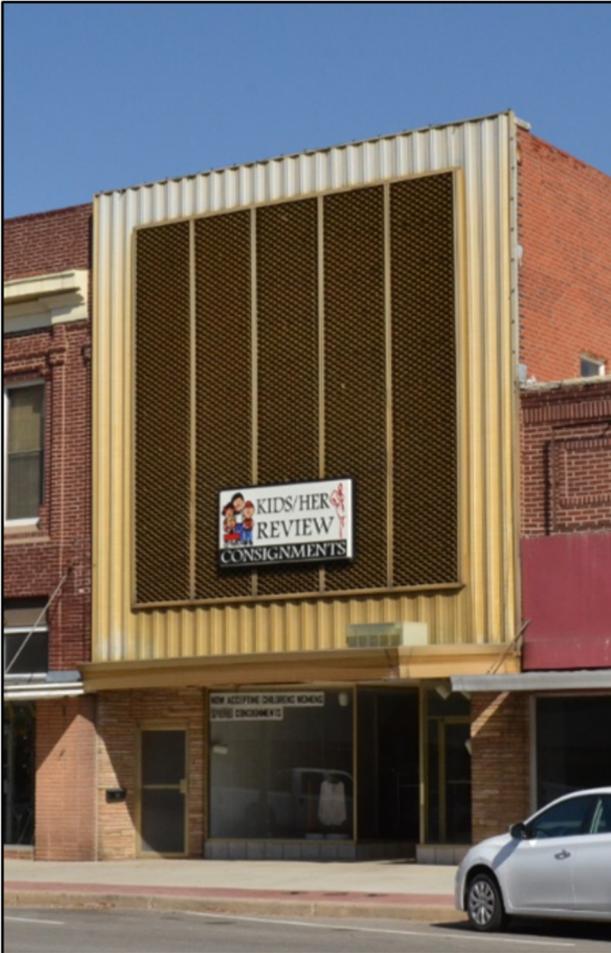
Figure 75: 309 East Grand Avenue. This building dates to 1911 but had an overall design change at the façade in the 1960s [2018 Survey].

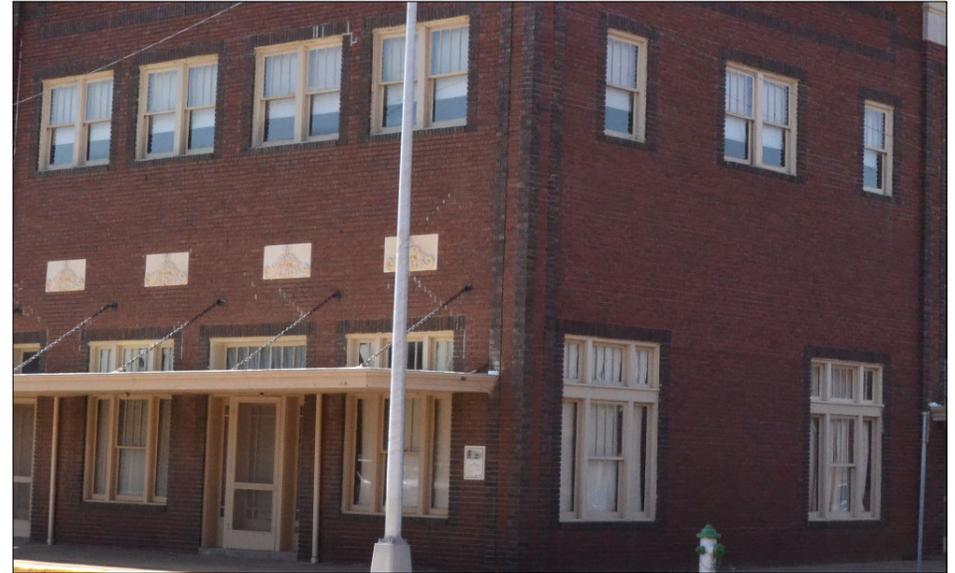
Figure 77: Gill's Mortuary Building, 122 North 2nd Street (1924), showing historic window and doors [2018 Survey].

- Maintain and retain historic doors and windows (Figure 77).
- Prioritize repair of windows on primary façades and nearest to ground level.
- When replacement is required, new doors and windows should match original features, size, shape, style, placement, configuration, and materials (including hardware) of the historic doors and windows. Operability does not have to match, but the appearance does (Figure 78).

- Keep wood windows and doors properly painted. (Figure 77)

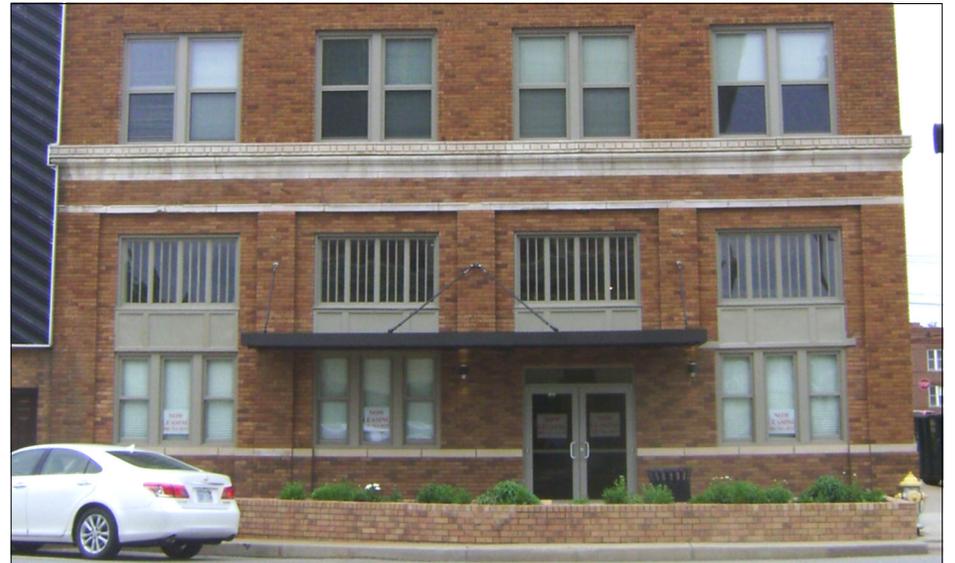
Figure 78: Community Building, 223 East Grand Avenue, showing compatible replacement windows [Rosin Preservation].

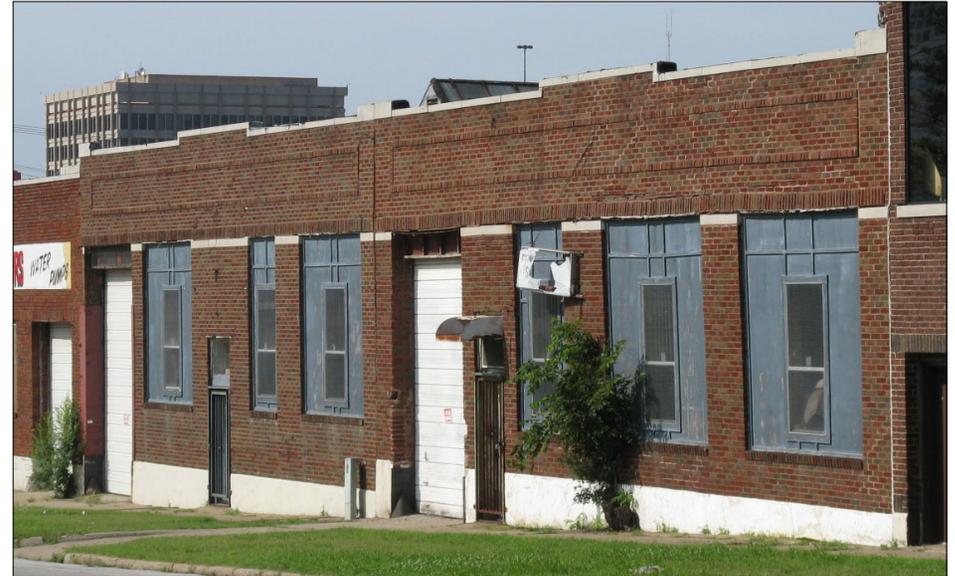
Figure 79: 28 North Guthrie Avenue, Tulsa. Windows sizes have been reduced. This is not a recommended treatment [Rosin Preservation].

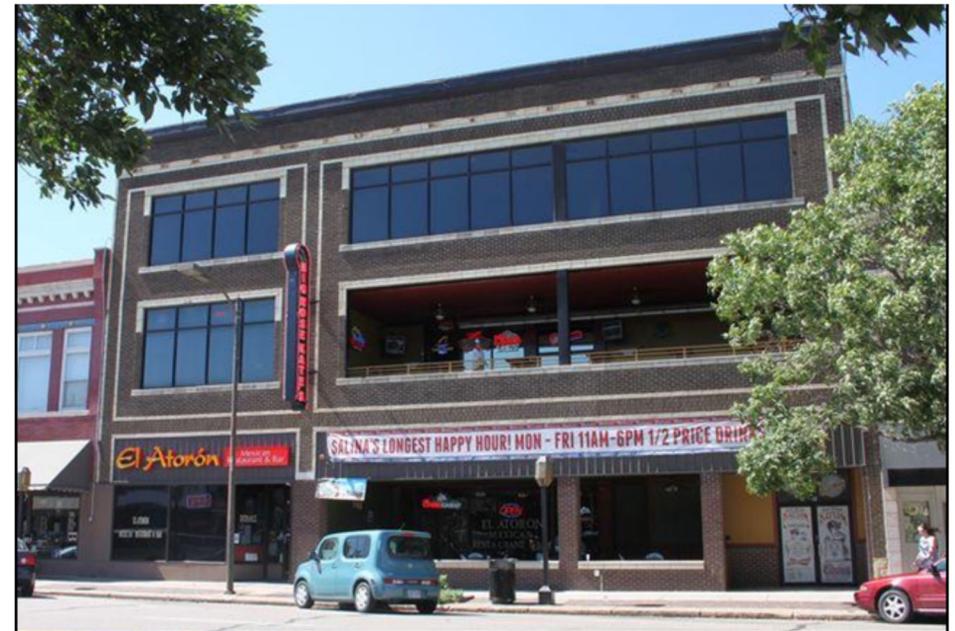
Figure 80: Commercial building showing masonry openings that historically contained windows and a storefront. This is not a recommended treatment [khri.org].

- Removing or recessing windows from their historic masonry openings (Figure 80).

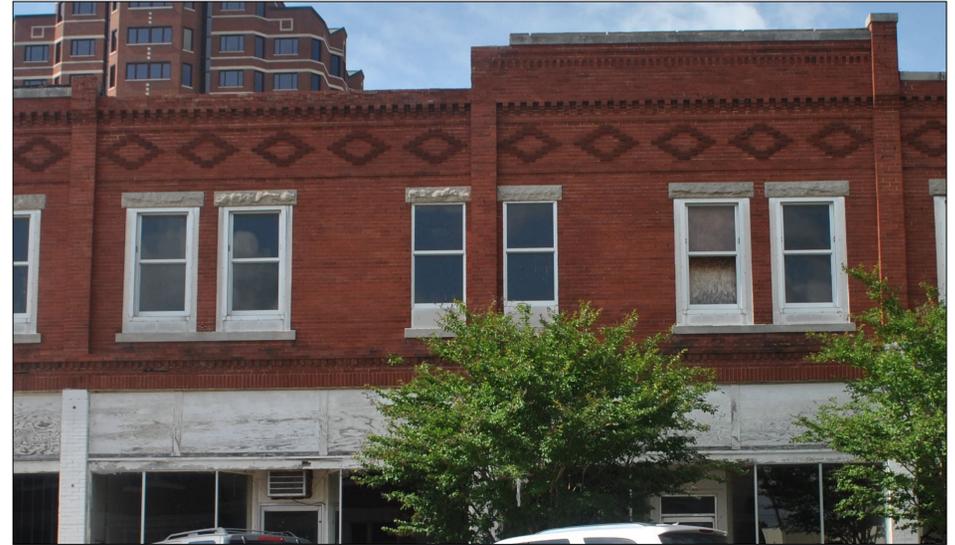
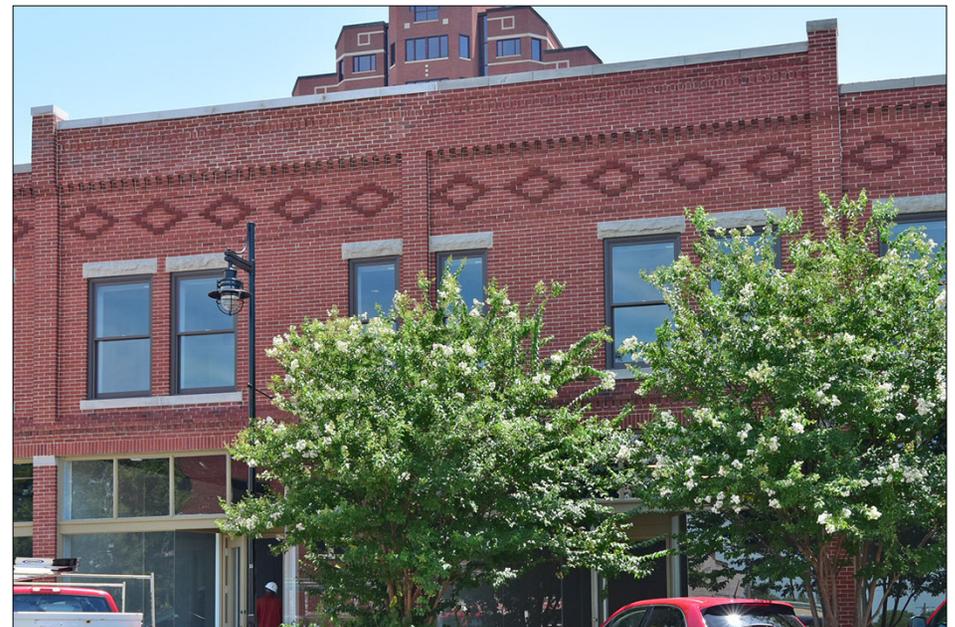
Figure 82: 119-125 West 2nd Street, Bartlesville. The missing portion of the brick parapet was rebuilt to match the historic appearance. Top photo is before restoration; bottom photo is after the parapet was rebuilt. Also, note the new windows match the size of the masonry openings [Rosin Preservation].
