HISTORIC DOWNTOWN PONCA CITY DESIGN GUIDELINES MANUAL

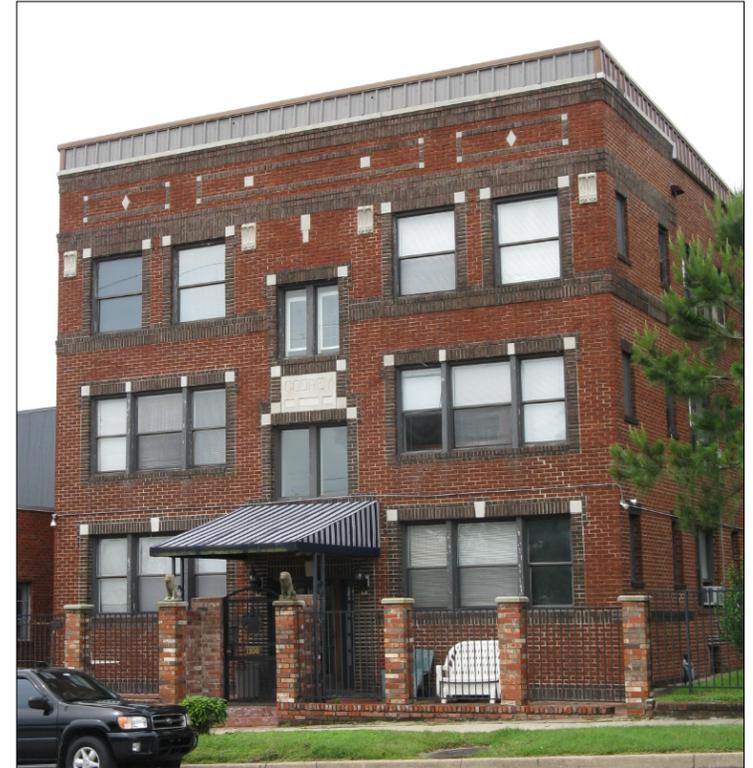
Figure 83: 1108 South Detroit, Tulsa. The parapet was either covered with metal or built up. This alters the appearance of the building. It is not a recommended treatment [Rosin Preservation].

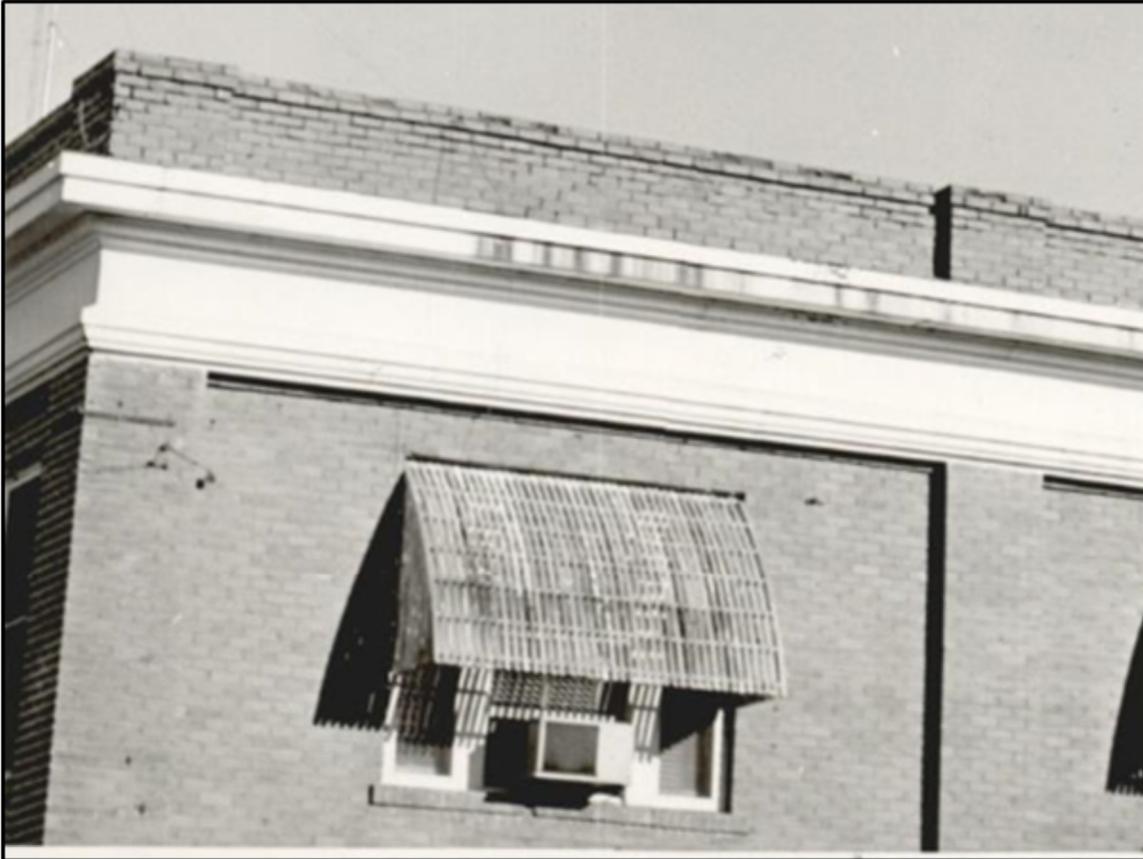
Figure 84: 200 East Grand in 1962, showing window air conditioner in upper story window [Gateway to Oklahoma History].

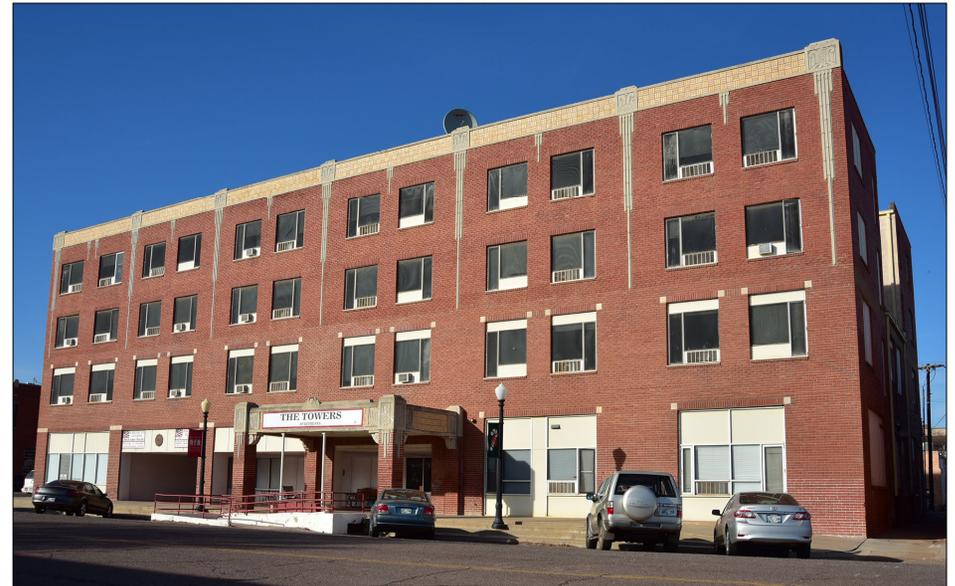
Figure 85: 107 East Commerce, Altus, showing window air conditioner units [Rosin Preservation].

- Installing through-wall air-conditioning units on the building (Figure 85).
- Installing window air-conditioning units on primary façades.
- Cutting channels into or removing historic façade materials to install utility lines or mechanical equipment, including exhaust hood fans, dryer vents, etc.
- Locating utility lines or utility boxes on the front façade of a building.

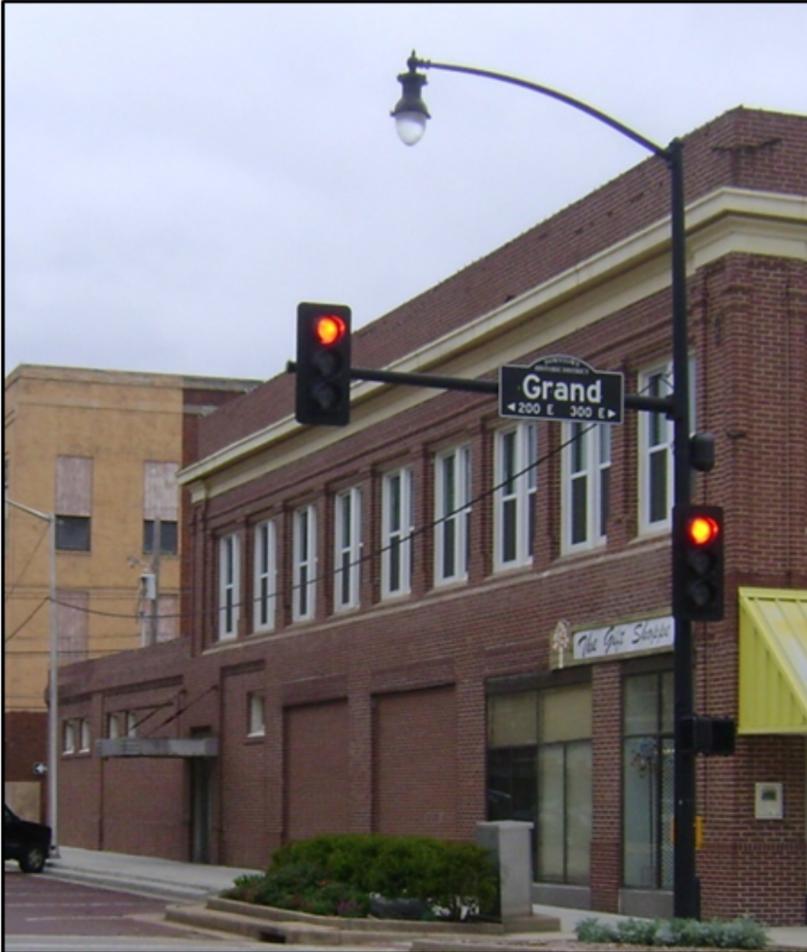
Figure 86: Example of historically compatible street lighting in downtown Ponca City [Rosin Preservation].

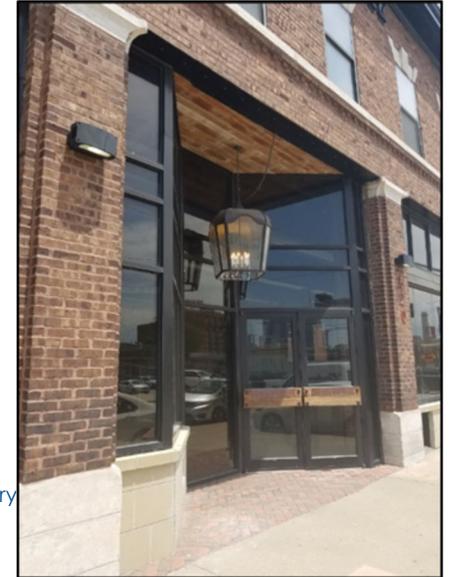
Figure 87: Pendant light is too large for this entry [Rosin Preservation].

- Choose a fixture that is appropriate for the district and building age. A carriage lamp, for example, on a 1930s building is inappropriate.
- Make sure the fixture is an appropriate scale for the building (Figure 87). Do not place a very large fixture next to a secondary entrance or a very small, residential type fixture next to a storefront.
- Where possible, install a fixture on a masonry wall utilizing mortar joints for mounting locations.
- Warm spectrum (white) lighting source is recommended.
- The most appropriate place for entry lighting is on the ceiling of the entry vestibule or under an awning (Figure 88). A simple ceiling mounted or pendant fixture is most appropriate.

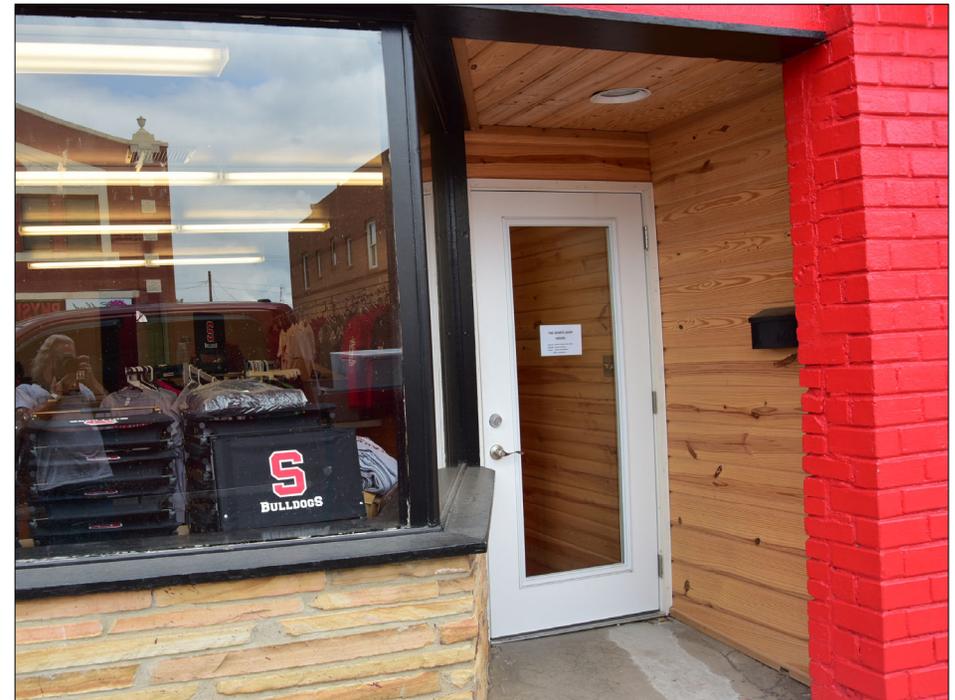
Figure 88: Indirect lighting at the entry is a preferred location for new lighting, as at 208 East Rogers Boulevard, Skiatook [Rosin Preservation].

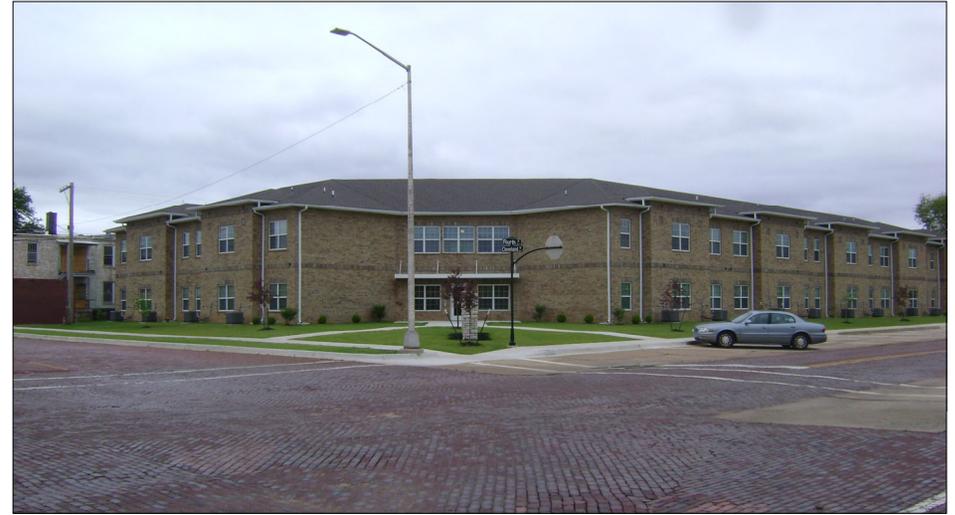
Figure 90: 315 East Cleveland is new infill to the north of the main downtown. The massing and height are compatible to the surrounding district [Rosin Preservation].

- New buildings should maintain the same setbacks as the historic buildings.
- New buildings should be proportional in size, scale, mass, and form to the adjacent historic buildings (Figure 90).
- Place additions to the rear of the property, if possible or on the roof.
- Additions should be compatible with the original structure but should be differentiated from the old.
- New additions should be designed in a manner that if removed in the future, the form and integrity of the historic structure will not be impaired.
- Additions should be smaller than the primary structure.
- Rooftop additions should not exceed one story in height.
- Keep additions simple and appropriate in shape, materials, color, and detail.
- Keep the massing, size, and proportion of the addition so that it does not compete with the existing property.

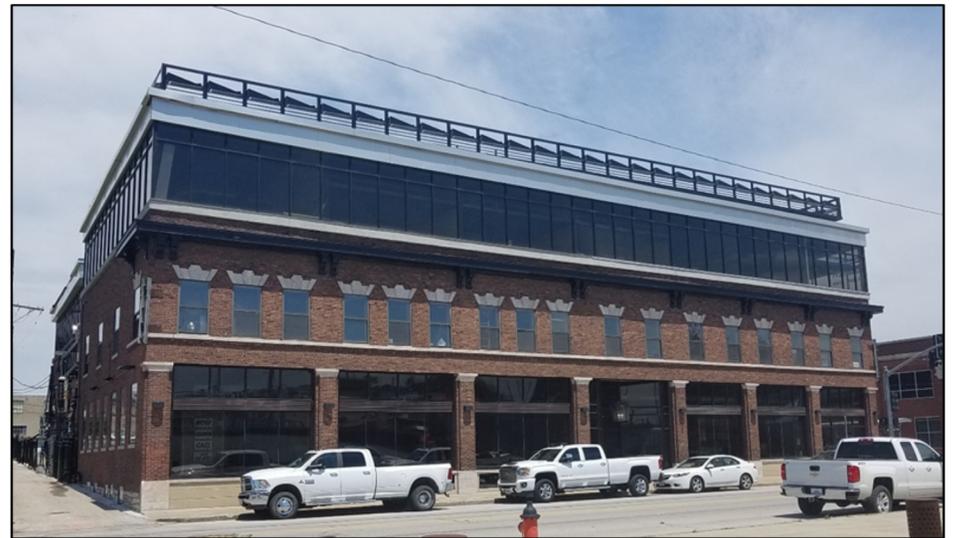
Figure 91: The rooftop addition of this building overshadows the historic building; this is an example of an inappropriate rooftop addition [Rosin Preservation].

- Locating additions on the primary façade or front of the property.
- Choosing a design and materials that are drastically stylistically different from the existing structure or that competes with the original structure.
- Constructing a rooftop addition on buildings less than four stories tall due to its visibility from the street.
- Constructing a rooftop addition that is taller than one story (Figure 91).

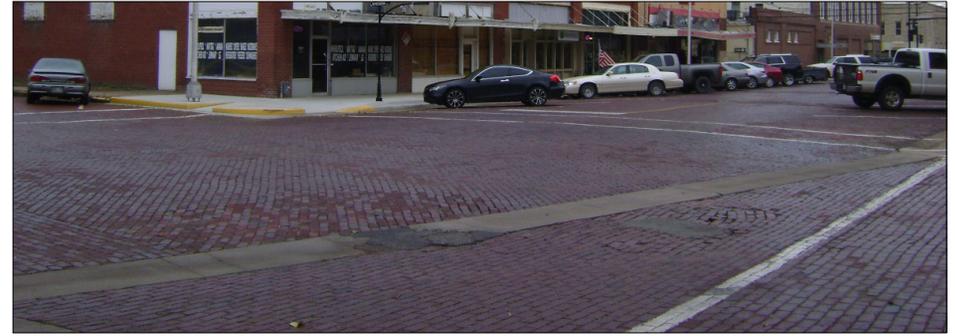
Figure 93: Ponca City's brick streets are character-defining features of the historic downtown [Rosin Preservation].

- New construction should be targeted for vacant lots along Grand Avenue.
- Historic brick paving should be retained and maintained (Figure 93).
- Vacant lots and parking areas should be landscaped (Figure 94).
- Parking lots should be kept to the interior of a block.
- Low fences may be allowed if they demarcate a business's outdoor seating area and do not obstruct pedestrian traffic.
- The street grid should be retained.
- Street objects should be consistent and match the overall architectural character of the district.

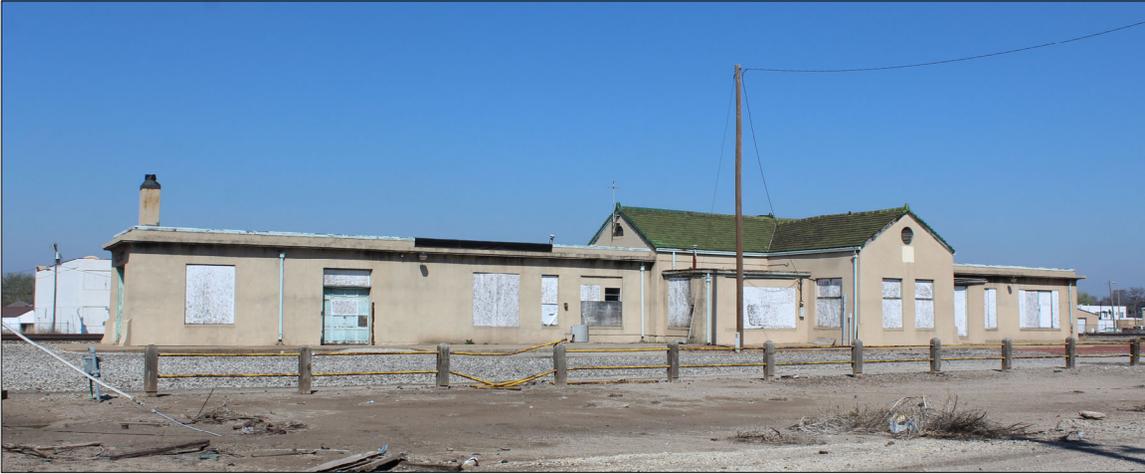
Figure 96: Ponca City Santa Fe Depot (1911) with plywood covered windows [2018 Survey].
